PERFORMANCE OF CONCRETE PAVEMENTS WITH OPTIMIZED SLAB GEOMETRY

Prepared By
Victor Cervantes
Jeffery Roesler
University of Illinois at Urbana-Champaign

Research Report ICT-09-053

August 2009

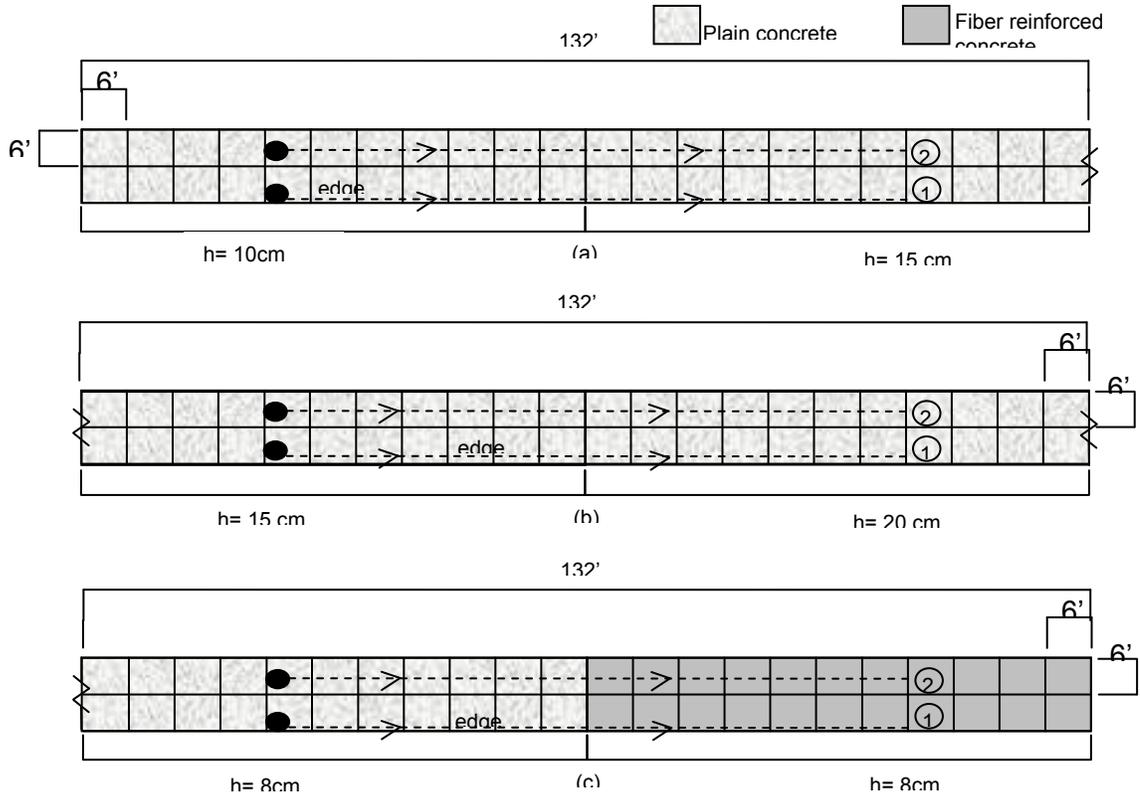
Figure 2. Test Sections for Accelerated Pavement Testing of Thin Concrete Pavement; (a) Section 1 with 10 and 15 cm sections on asphalt concrete base; (b) Section 2 comparison of 15 and 20 cm sections on an aggregate base; (c) Section 3 comparison of 8cm section on aggregate base with and without fiber reinforced concrete.

As seen in Figure 2 (a), the first test section will determine the performance difference between the 10 and 15 cm on an asphalt concrete base layer. Figure 2 (b) shows the second test section which will determine the performance of 15 and 20 cm slab thickness on an aggregate base layer. Finally, Figure 2(c) will determine the structural benefit and performance of concrete made with and without discrete fiber reinforcement for a constant slab thickness of 8 cm on an aggregate base layer. A comparison between the three test sections' performances can also be made to later determine the optimal thickness for a given traffic level and also against accepted cracking models such as RiPPER model (Smith et al. 1998) and the M-EPDG (ARA 2007). There are no dowels or tie bars in the test sections and the joints are not sealed.

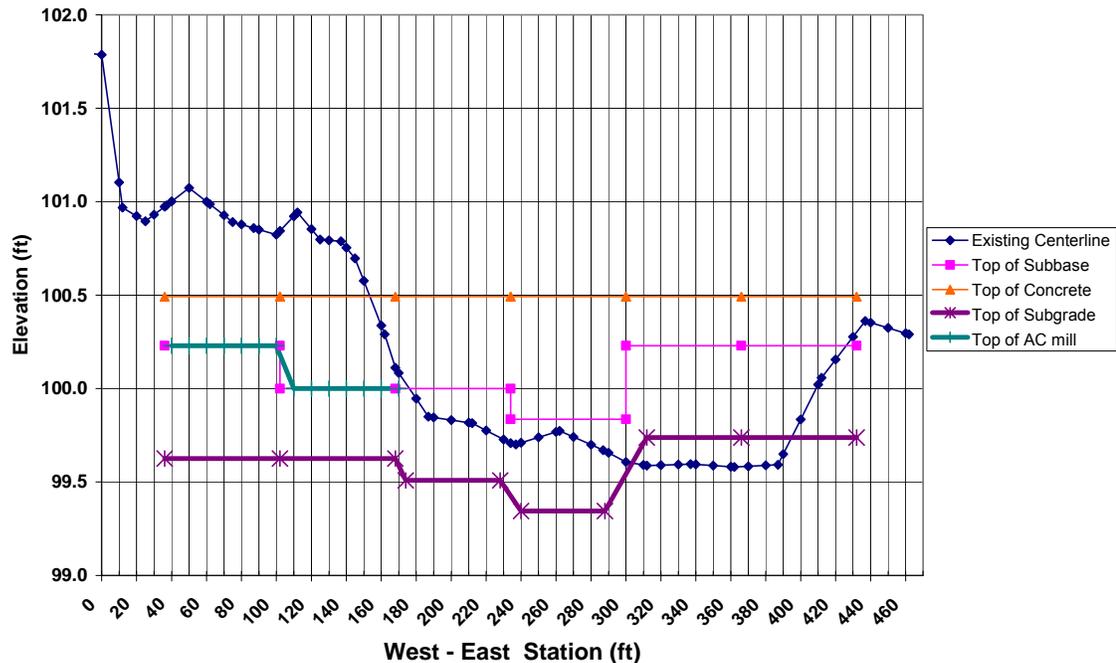
Figure 5. Profile of project site. Test section begins at station 36 (ft).

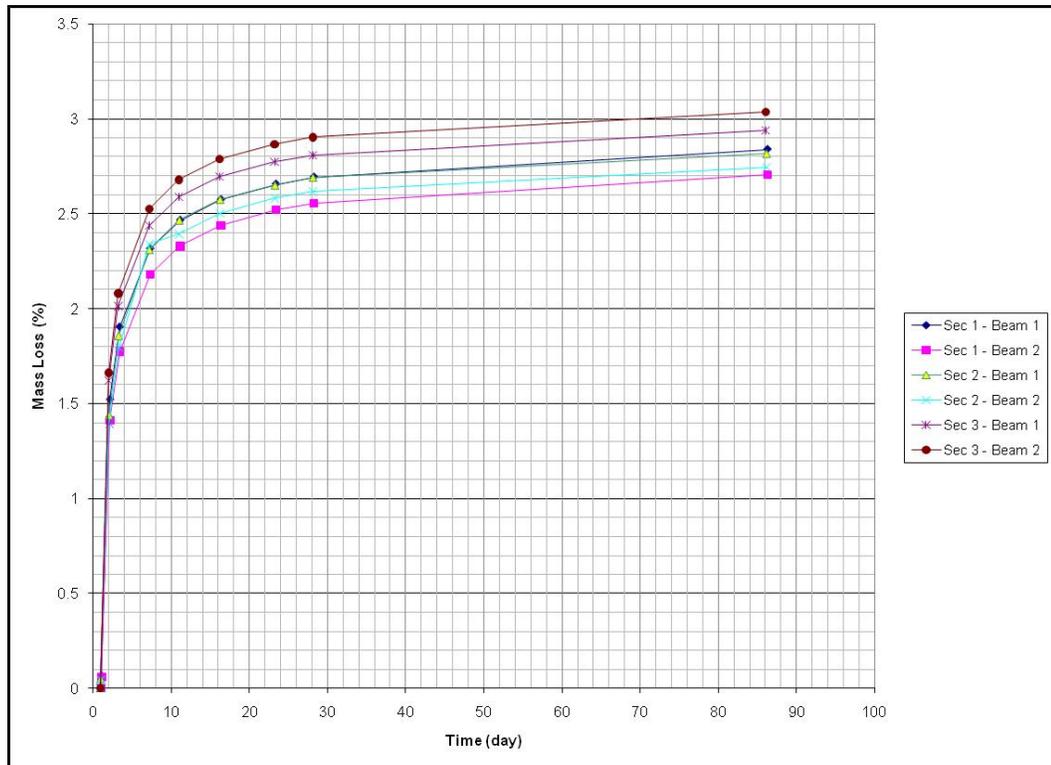
Figure 6. Mass loss data for TCP.

Figure 7. At 86 days, the mass loss percentage between the highest and lowest percentage loss varied by only 0.33%. The greatest mass loss was for the fiber mix.

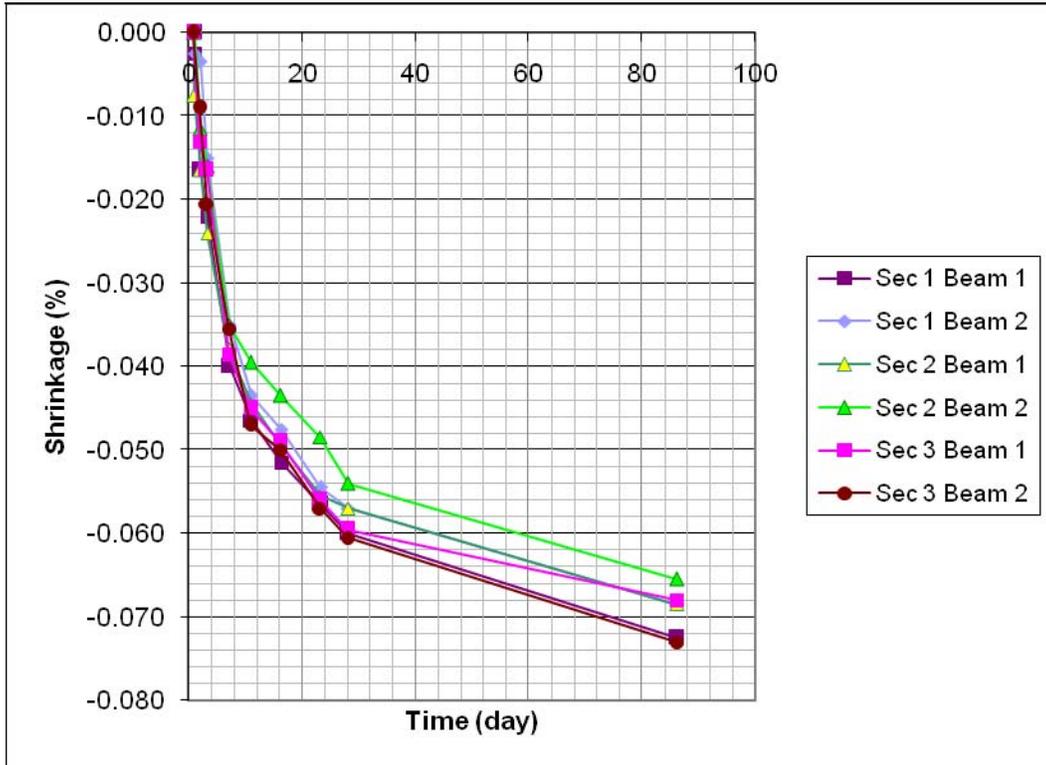
Figure 7. Shrinkage data for TCP.

Figure 7 is a plot of free drying shrinkage percentage versus time (ASTM C157). Up until about 11 days the shrinkage percentage is about the same for all of the specimens. At about 90 days the second beam for section 3 had the lowest shrinkage percentage at -0.073%. The highest shrinkage percentage was for section 2 (specimen 2) at -0.066%. The difference between these two beams is 0.007 % which shows that there is little difference in shrinkage percentage between the plain concrete and the FRC mixtures.

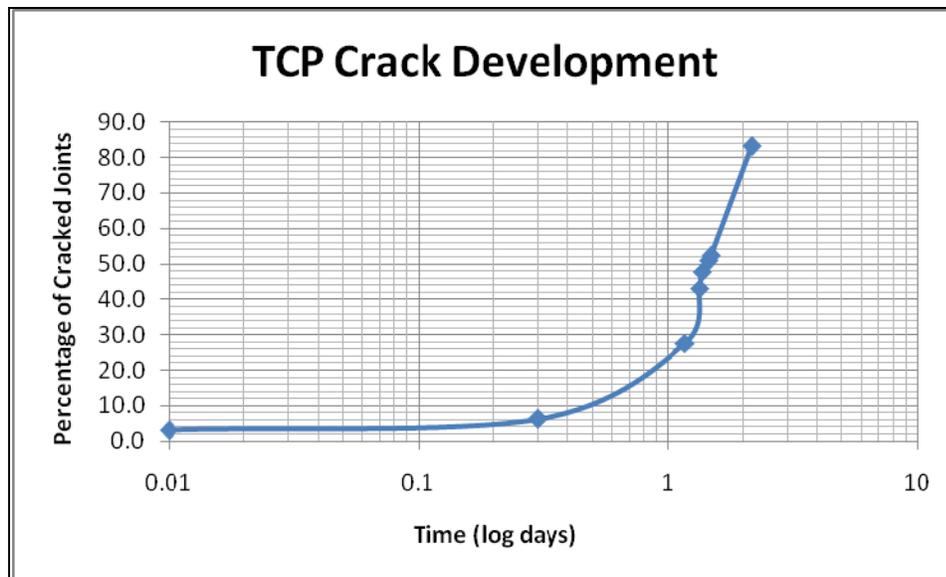
Figure 18. Plot of first observation of crack at a specific joint.

The concrete slabs were periodically inspected for the initiation of the joint cracks. Figure 18 is a graphical representation of the percentage of cracked joints as a function of days after construction of the section. Table 3 presents the percentage of slab joints that were cracked on the day of inspection. After 15 days 28% of the joints had cracked, primarily on the thinner sections. By 31 days the number of cracked joints increased to 52% and after 5 months 83% of the joints had cracked. One observation to note is that on the day after the concrete slabs were cast a hairline transverse crack appeared on the south side of slab 51. By day 28, the transverse crack had propagated across to the north side slab. This was the only random crack observed in the test pavement. The crack was near the location where all of the thermocouple wire exited the pavement that connected to the data logging system. The transverse crack was not noticed at the other data logger location because that pavement section was 15 cm on an asphalt base as opposed to 8cm on a granular base.

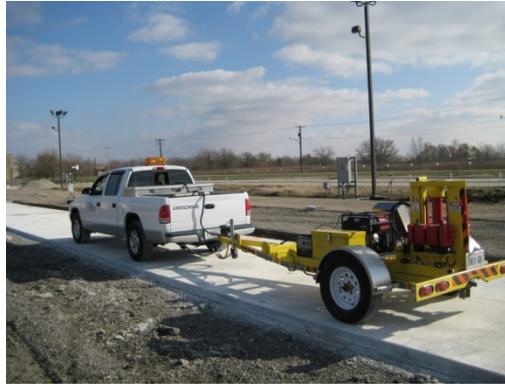
Figure 19. FWD used for center slab deflections and joint load transfer efficiency.

Falling weight deflectometer (FWD) analysis was conducted on the north row of concrete slabs 29 days after casting. Figure 19 is a photograph of the FWD device that was utilized. The center slab normalized deflections for 9-kip load are plotted versus the slab number in Figure 20. This plot confirms that the deflection is the smallest when the concrete slabs are supported by the asphalt concrete layer (section 1). Section 2a had higher deflections than section 2b as expected due to its thinner slab thickness (15 versus 20 cm). The highest deflection was observed at slab 56 which is the transition slab between the 8cm plain and fiber reinforced concrete section.

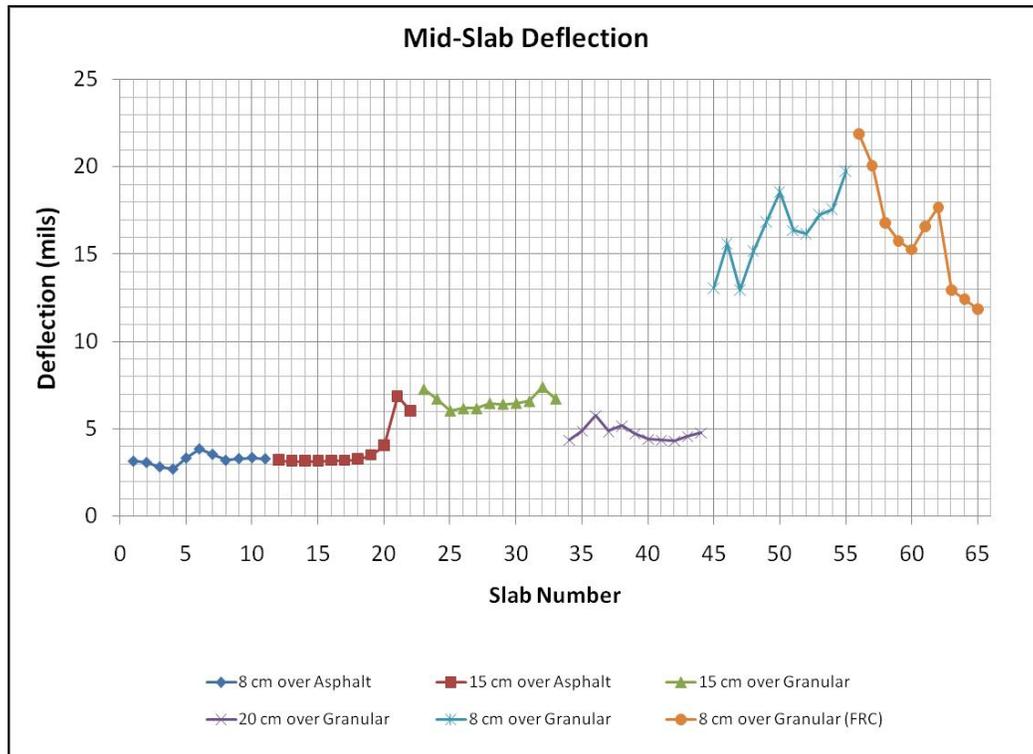
Figure 20. Center slab 9-kips normalized deflections (mils=0.001 inch).

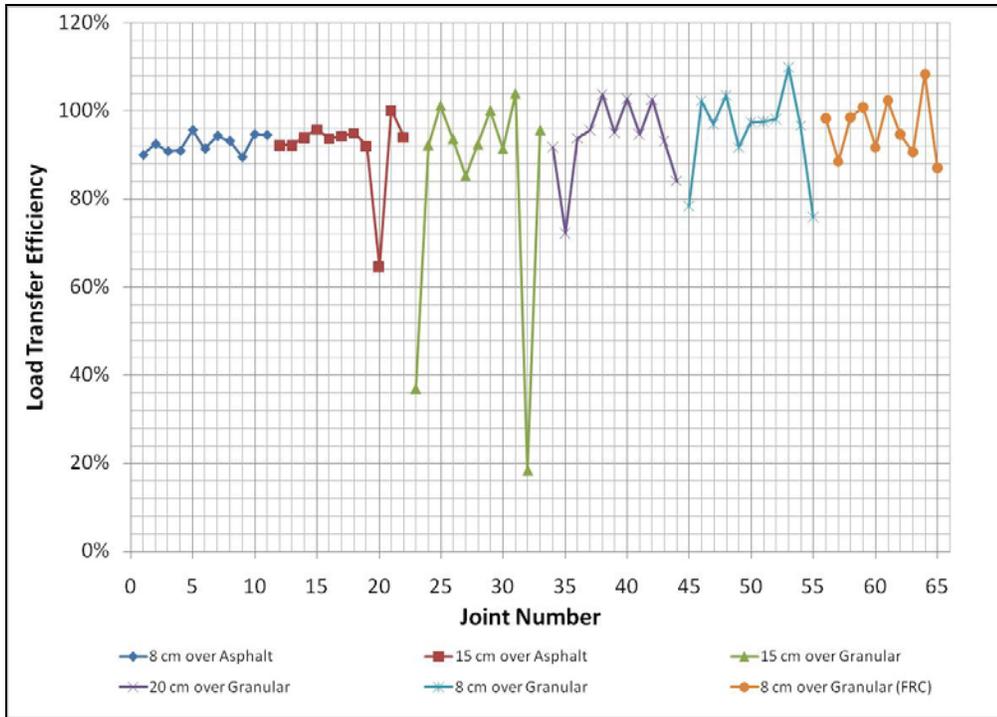
Figure 21. Load transfer efficiency of transverse contraction joints.

The load transfer efficiency (LTE) across each of the joints was calculated from the FWD data as seen in Figure 21. Joints 20, 23, 32, 35, 45, and 55 had a LTE less than 80%. These joints were some of the first to form full-depth cracks after the pavement had been cast. Figure 22 shows the deflection at a given joint.

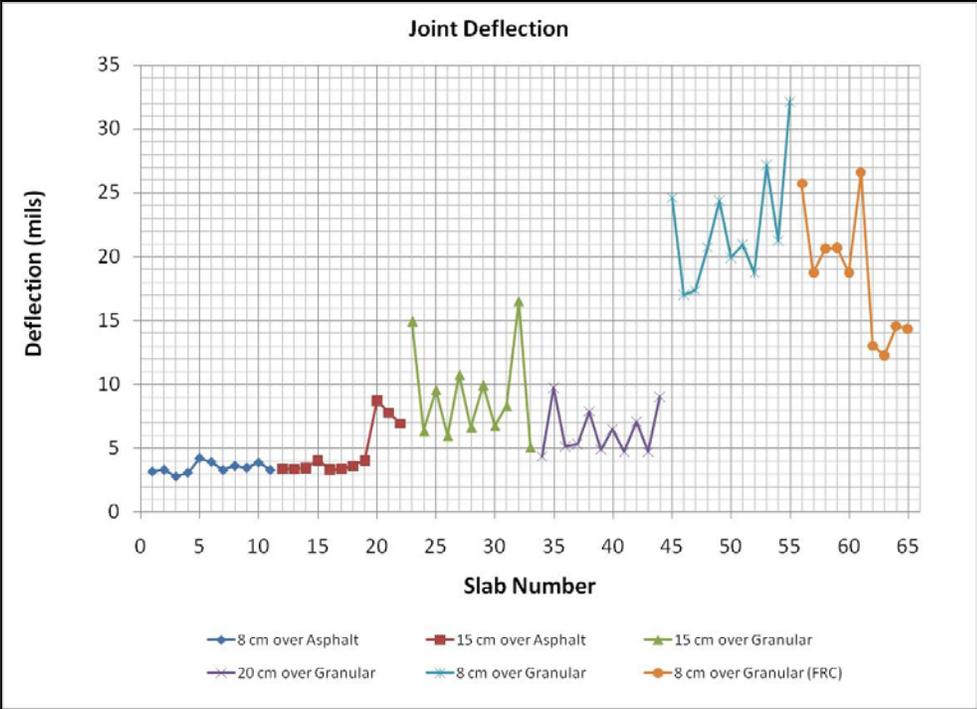
Figure 22. 9-kip deflection at a given joint location.

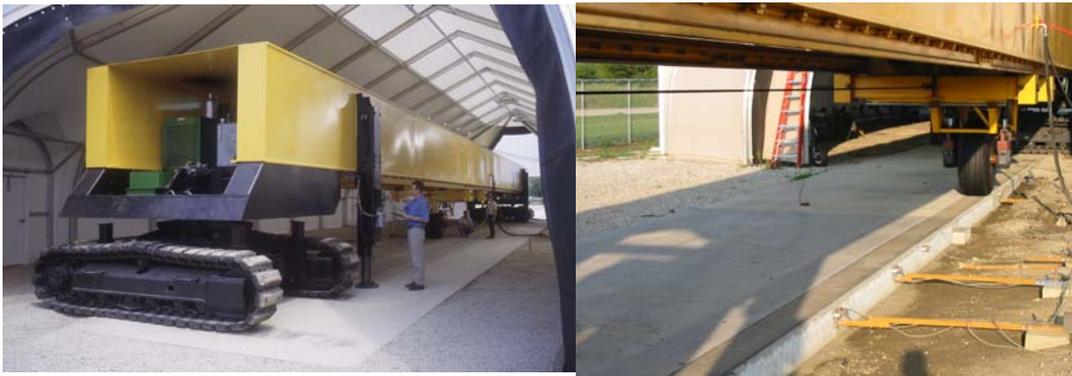
Figure 23. Accelerated Transportation Loading Assembly (ATLAS) device.

The ATLAS device, seen in Figure 23, was utilized to complete the response and failure testing of the three test sections. The ATLAS is approximately 124 ft long, 12 ft. high, and 12 ft. wide and weighs 180-kips. The loading length of the ATLAS is 85 ft., which can be programmed for either uni- or bi-directional movements. In this testing, only uni-directional testing was employed. The machine transmits a load up to 80,000 pounds to the pavement through a hydraulic ram attached to a wheel carriage. The wheel carriage assembly can accommodate a single tire, dual-wheel tire, or an aircraft tire. For most of the testing, an aircraft tire was used except for some trafficking with a super single tire on section 3. A winch motor pulls the wheel carriage back and forth on the test section. The ATLAS could apply approximately 2,500 repetitions per day in the uni-directional mode. The ATLAS is mounted on two pairs of rotating crawler tracks, which provide translational and rotational maneuverability of the ATLAS around the testing grounds. For most of the test sections, the ATLAS was exposed to the ambient conditions except for section 3 (north) where the temperature panels enclosed the test section.

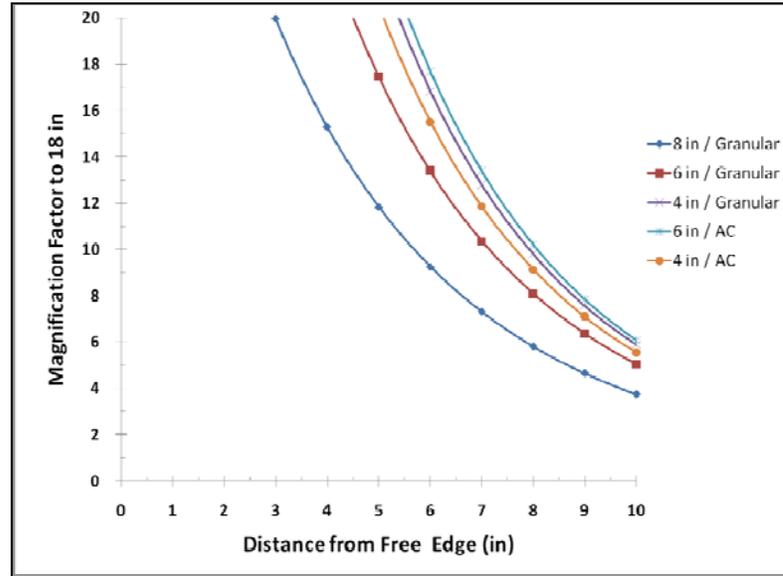
Figure 24. Lateral offset magnification factor for the various concrete test sections.

trafficking would have to be approximately 5.5 inches away from the edge for the case of the 8 inch pavement over the granular base. During the trafficking of the sections, the wheel was typically offset from the free edge approximately 4 to 5 inches, thus the magnification factor was calculated based on a 5-inch lateral offset with a maximum value of 20 as shown in always more than the original conservative value of 10. A magnification factor was not used when the load was applied in the wheel path, which was offset 12 inches laterally from the edge.

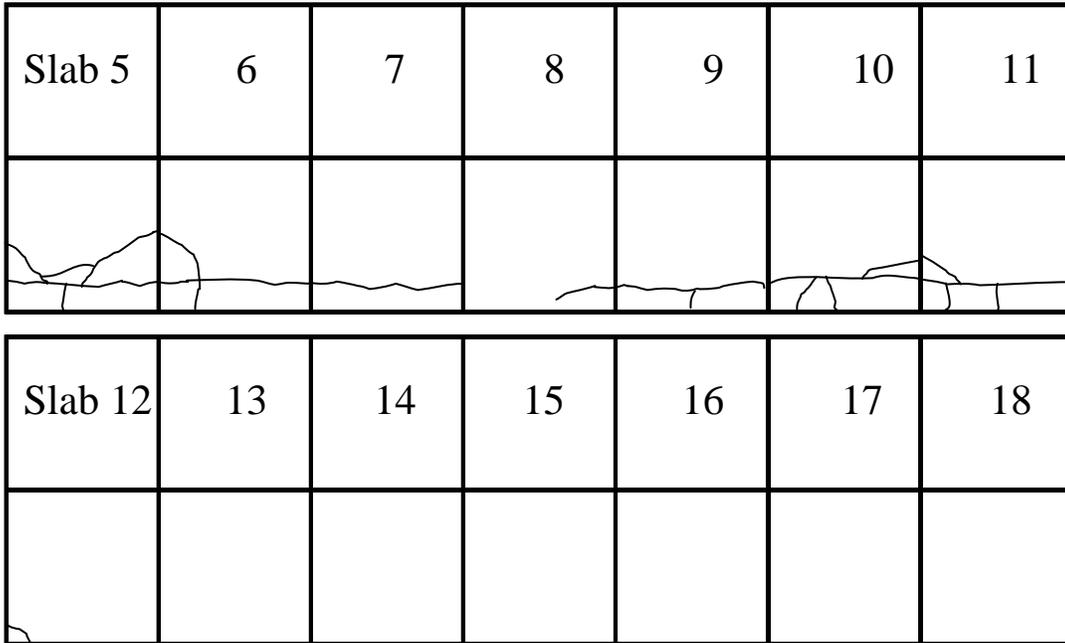
Figure 28. Section 1 south cracking performance after 5/14/09 testing (44 Million ESALs).

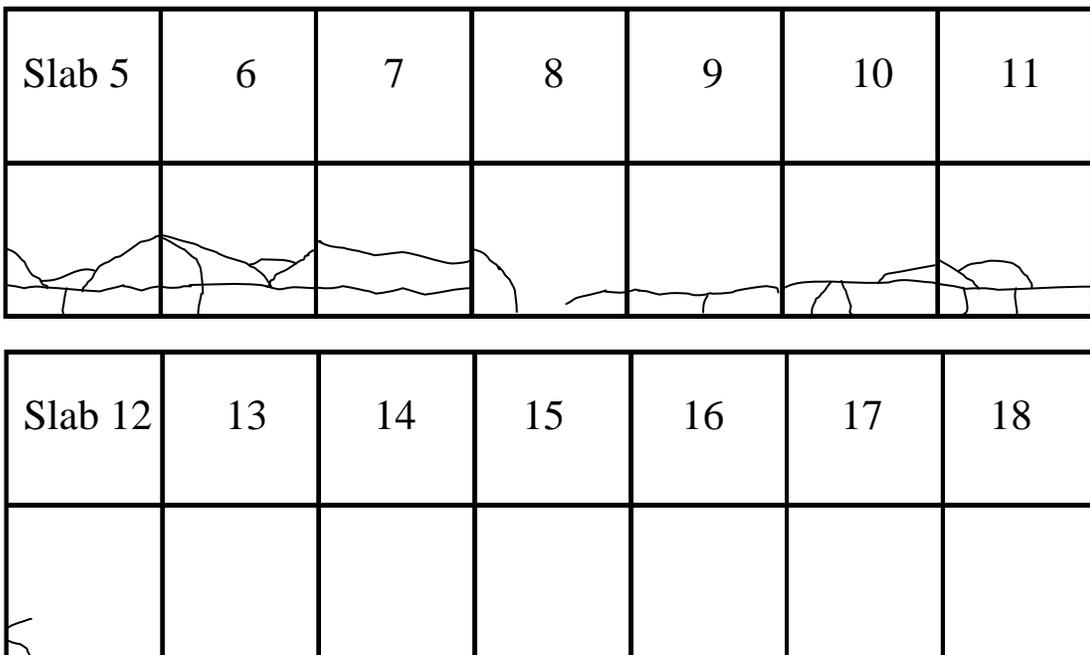
Figure 29. Section 1 south cracking performance after 5/15/09 testing (57.5 Million ESALs).

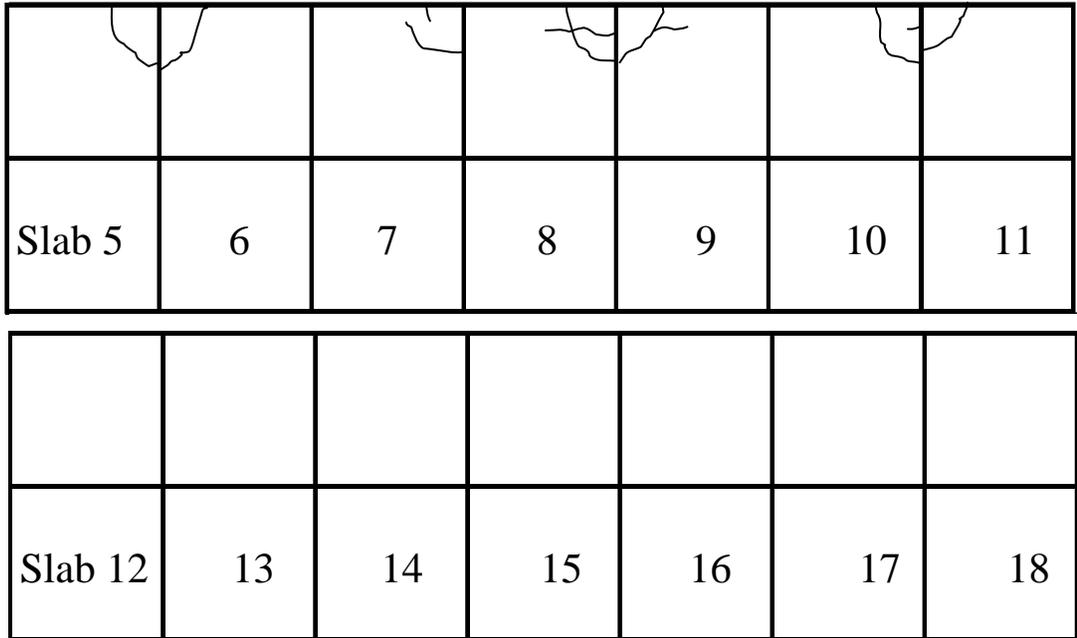
Figure 31. Section 1 north cracking performance after 4/21/09 testing (2.2 Million ESALs).

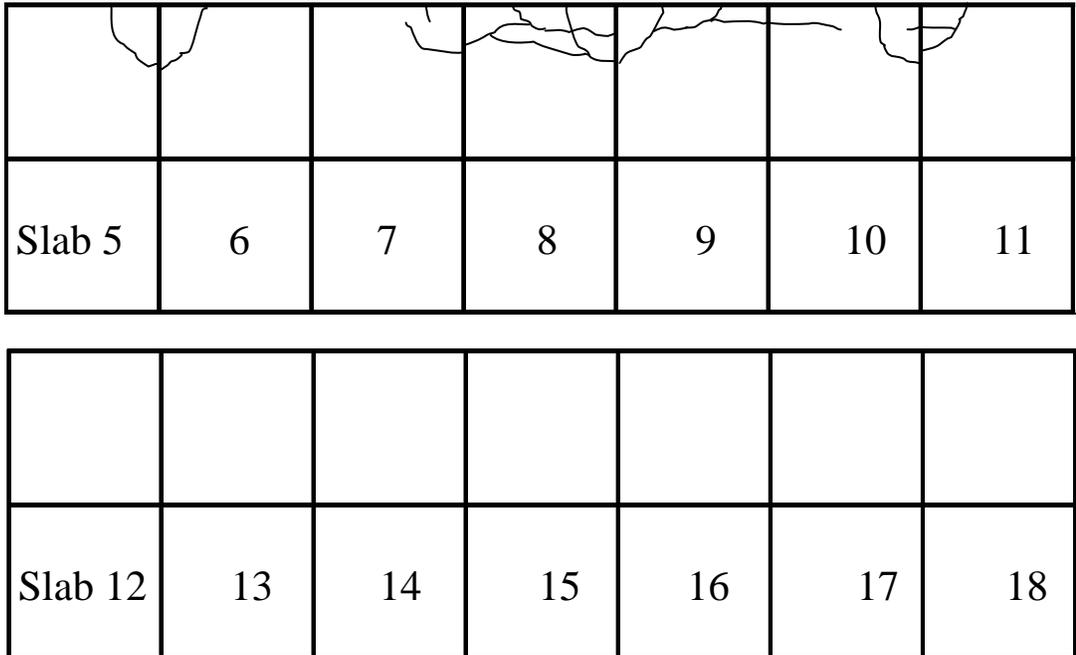
Figure 32. Section 1 north cracking performance after 4/22/09 testing (6.3 Million ESALs).

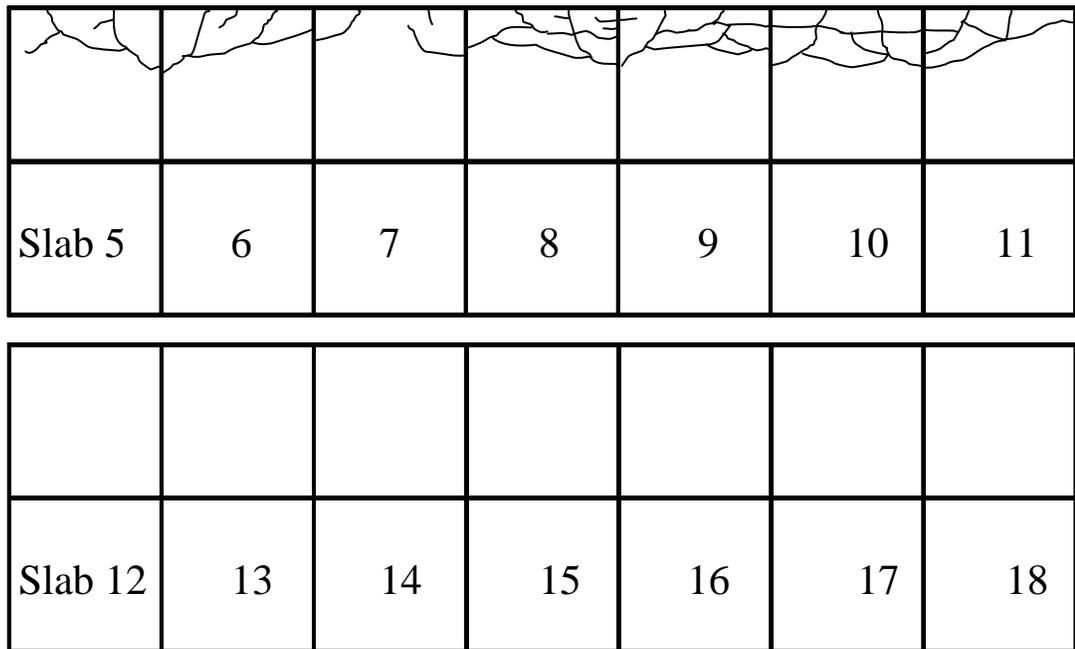
Figure 33. Section 1 north cracking performance after 4/23/09 testing (13.2 Million ESALs).

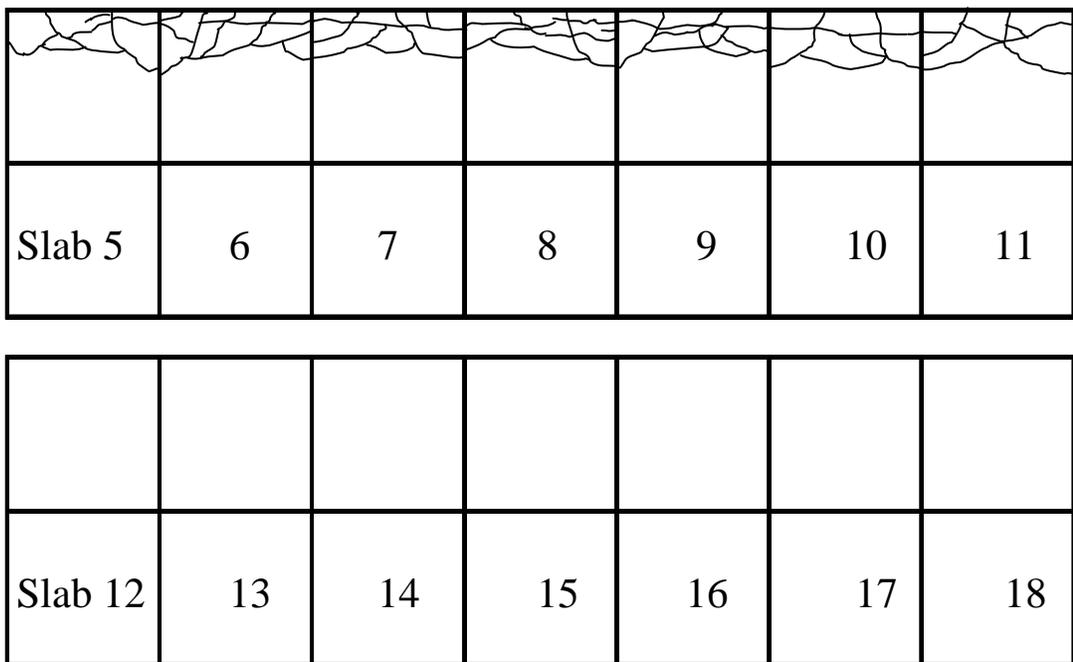
Figure 34. Section 1 north cracking performance after 4/24/09 testing (21.6 Million ESALs).

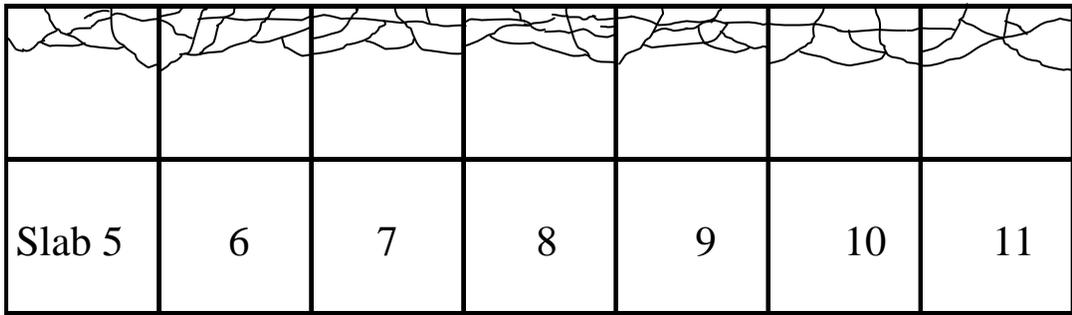
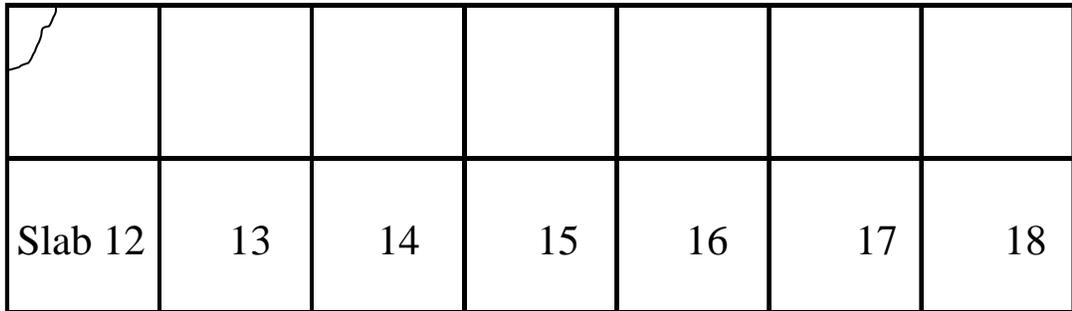
Figure 35. Section 1 north cracking performance after 4/25/09 testing (30.6 Million ESALs).

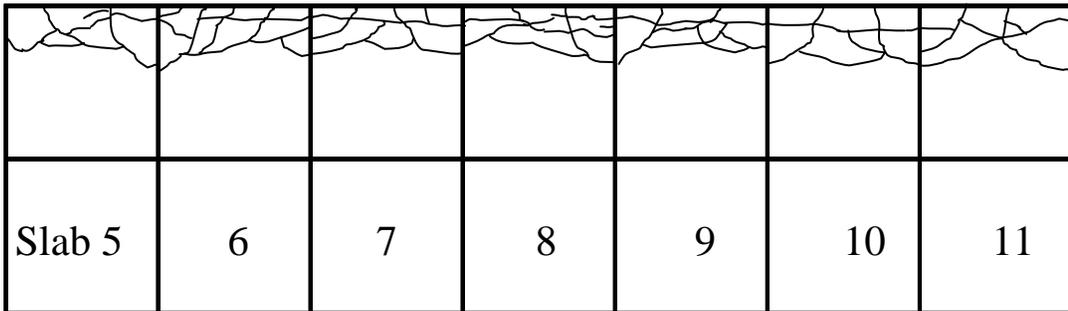
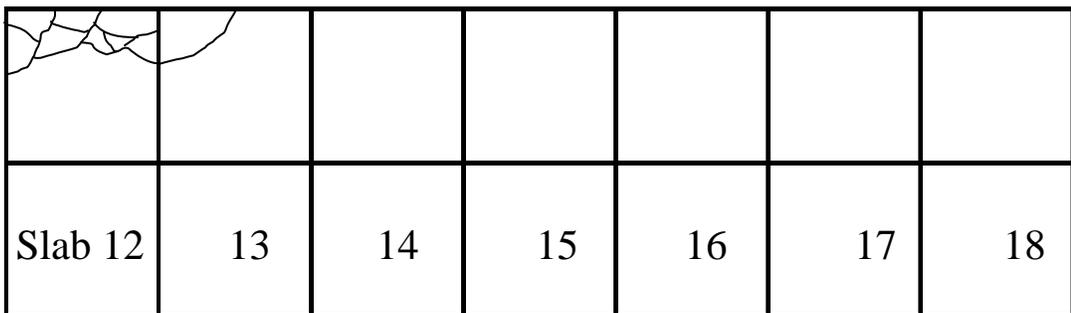
Figure 36. Section 1 north cracking performance after 4/26/09 testing (51.6 Million ESALs).

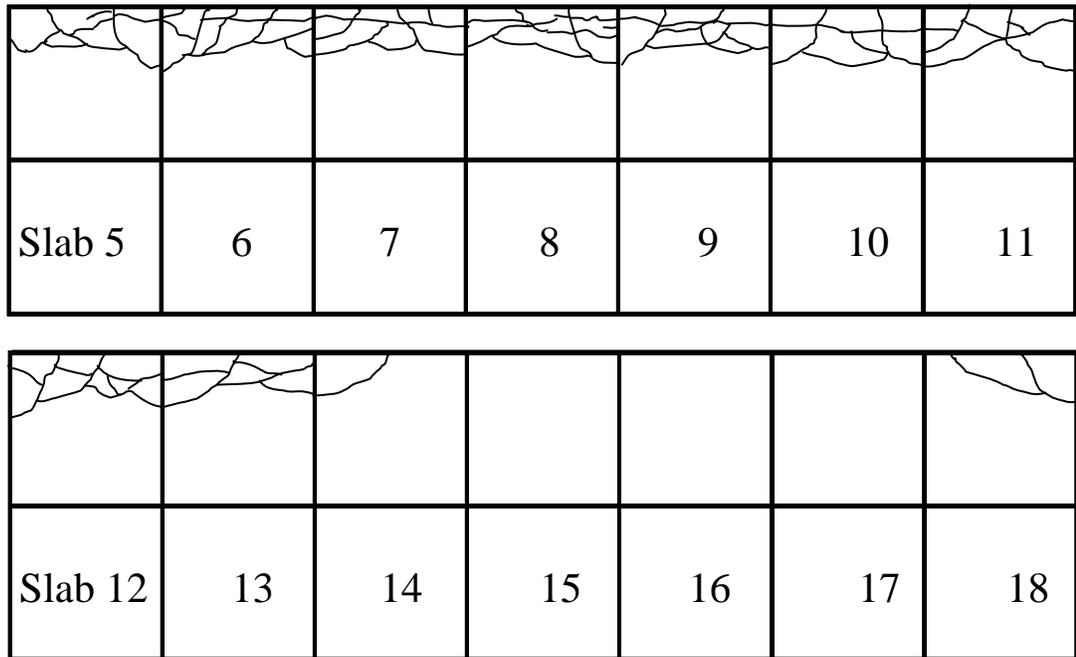
Figure 37. Section 1 north cracking performance after 4/27/09 testing (69.3 Million ESALs).

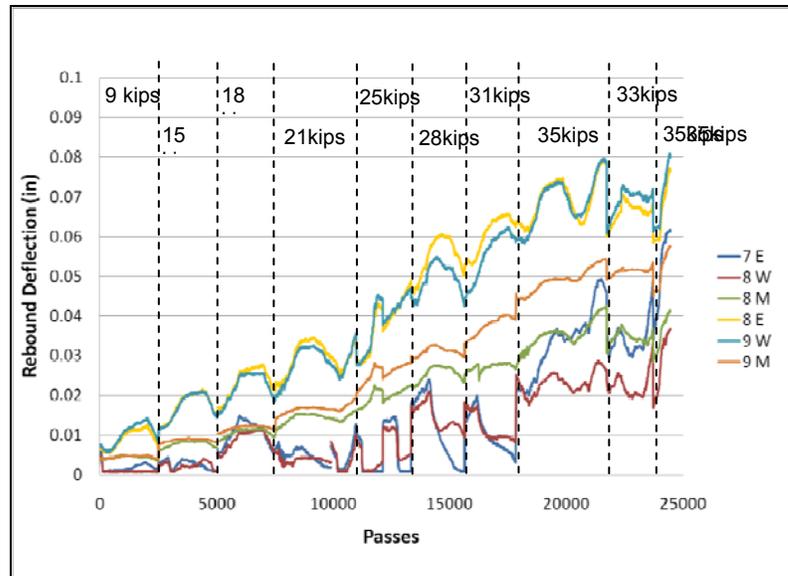
Figure 39. Rebound deflections of 4 in. concrete slab over 6.5 in. asphalt concrete (Section 1-south).

The rebound deflections on both the 4 inch and 6 inch part of section 1 (south) were similar as seen in Figure 39 and Figure 40. This behavior was due to the slabs being supported by a relatively thick asphalt base layer. However, in terms of cracking, all the 4 inch slabs cracked before any of the 6 inch slabs cracked.

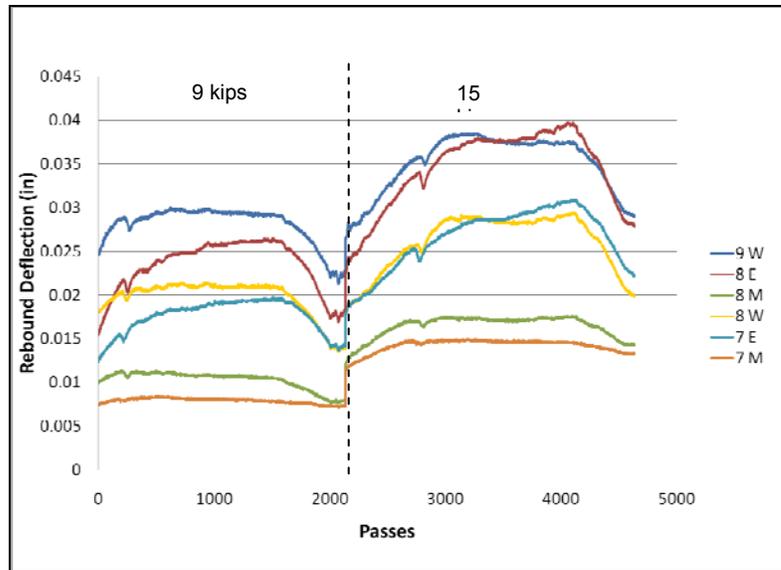
Figure 41. Wheel path rebound deflection of 4 in. concrete slab over 6.5 in. asphalt concrete (Section 1-north).

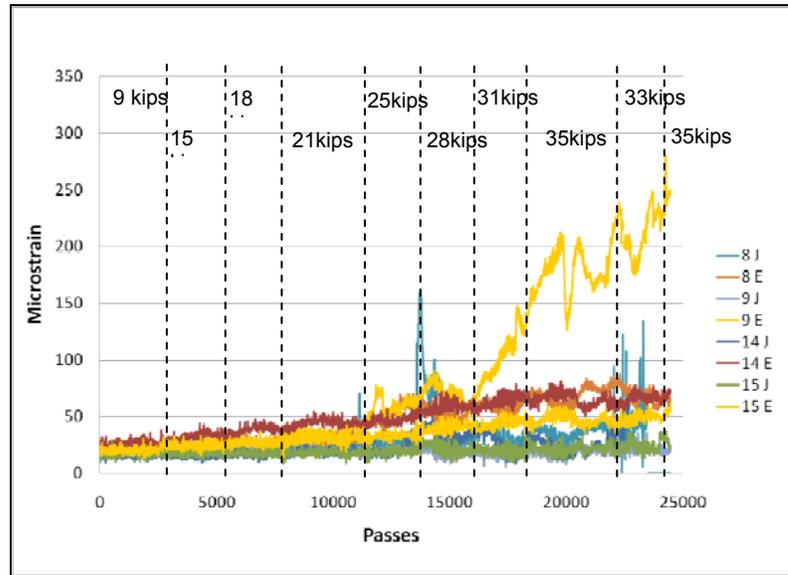
Figure 45. Tensile strain responses for 4 in. and 6 in. concrete over asphalt concrete (Section 1-north).

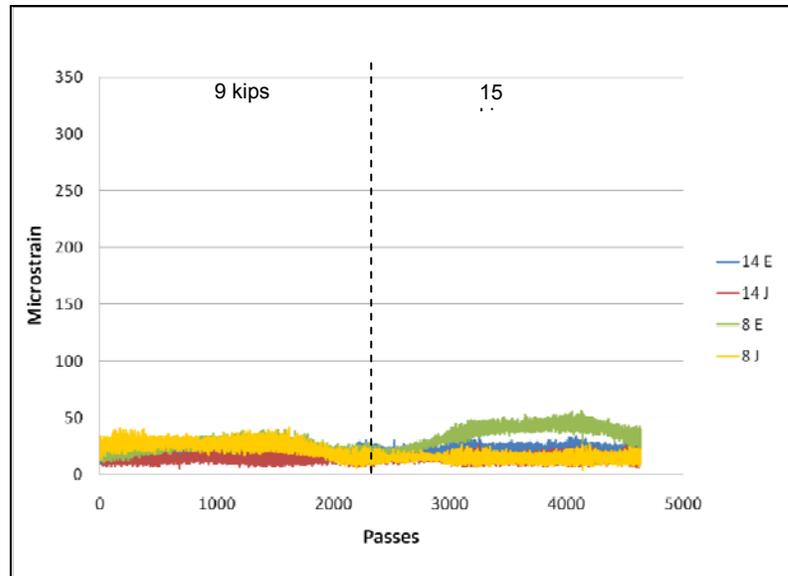
Figure 46. Wheel path tensile strains responses for 4 in. and 6 in. concrete slabs over asphalt concrete (Section 1-north).

Figure 46 is the plot of the strain data that was collected when section 1 (north) was trafficked along the wheel path. The tensile strain levels were below 50 microstrain even with a 15-kip single wheel load. When the loading location was moved to the edge, the strain magnitudes for the 4 inch section increased past 100 microstrain as shown on Figure 47. Surface cracking was seen after 5,000 repetitions on the 4 inch which can be seen in Figure 47 as the region where the strains increase more dramatically. Note, strain measurements will either increase or decrease depending on the location of the crack relative to the strain gauge.

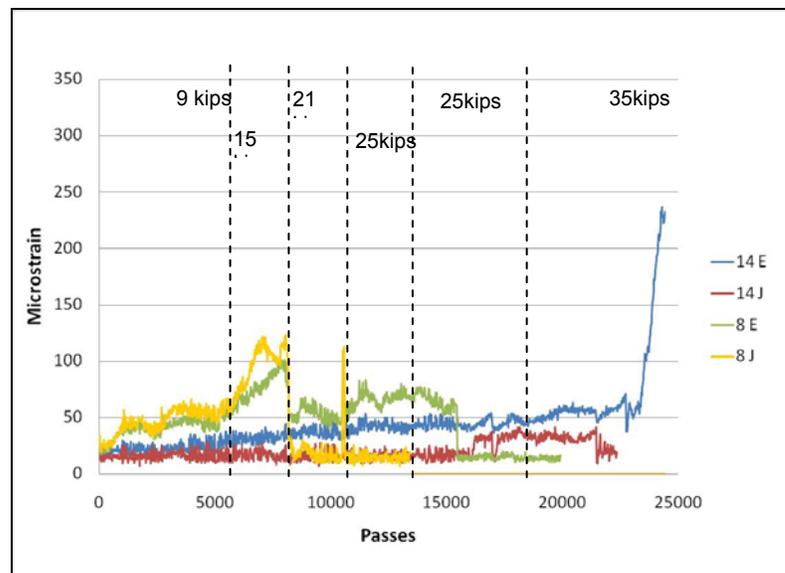
Figure 47. Edge loading responses for 4 in. and 6 in. concrete slabs over asphalt concrete (Section 1-north).

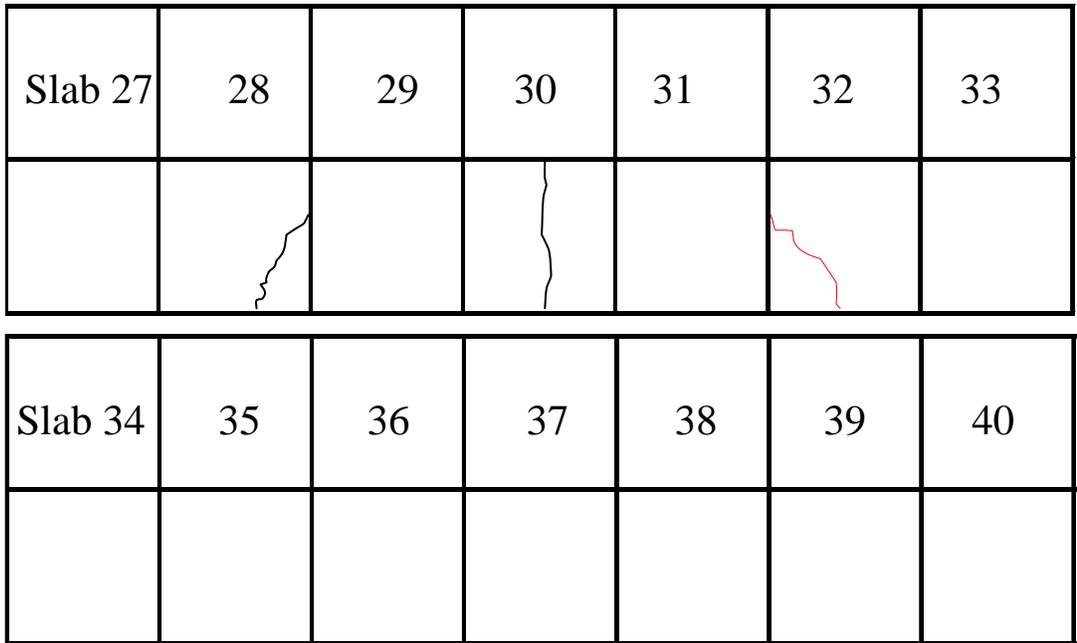
Figure 49. Section 2 south cracking performance after 5/9/08 testing (6 inch=20.2 Million ESALs; 8 inch=17.2 Million ESALs).

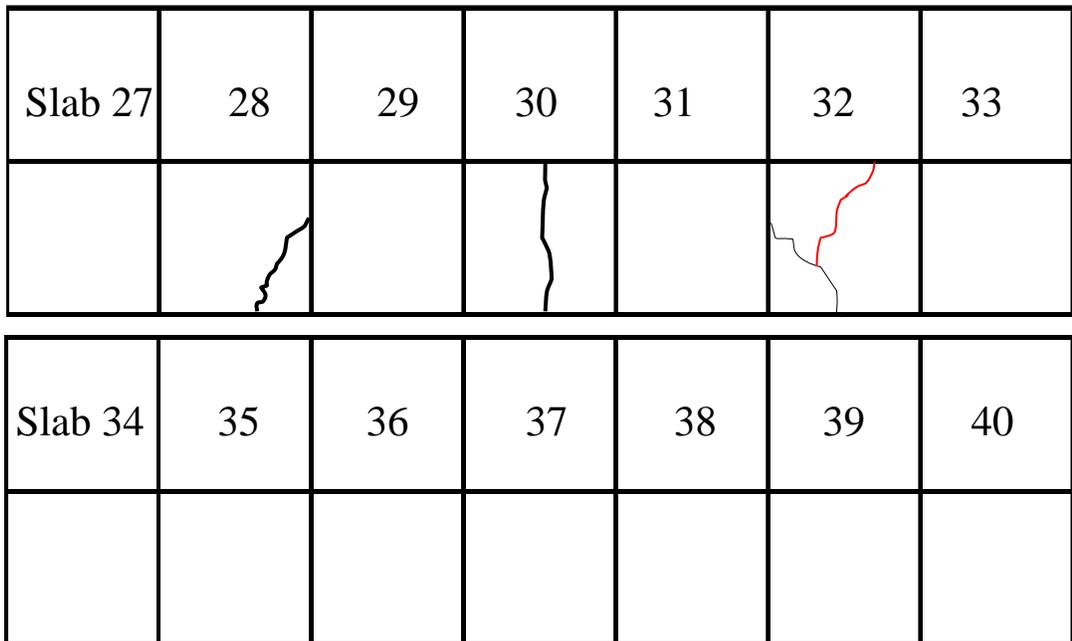
Figure 50. Section 2 south cracking performance after 5/10/08 testing (6 inch=22.5 Million ESALs; 8 inch=19.2 Million ESALs).

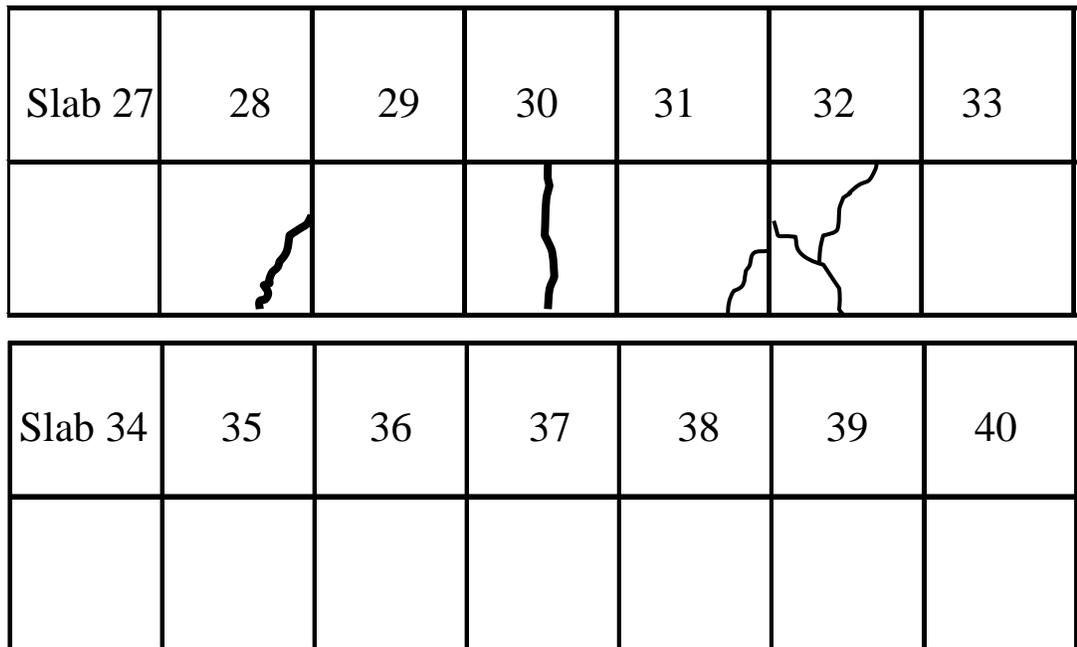
Figure 51. Section 2 south cracking performance after 5/12/08 testing (6 inch=22.9 Million ESALs; 8 inch=19.5 Million ESALs)

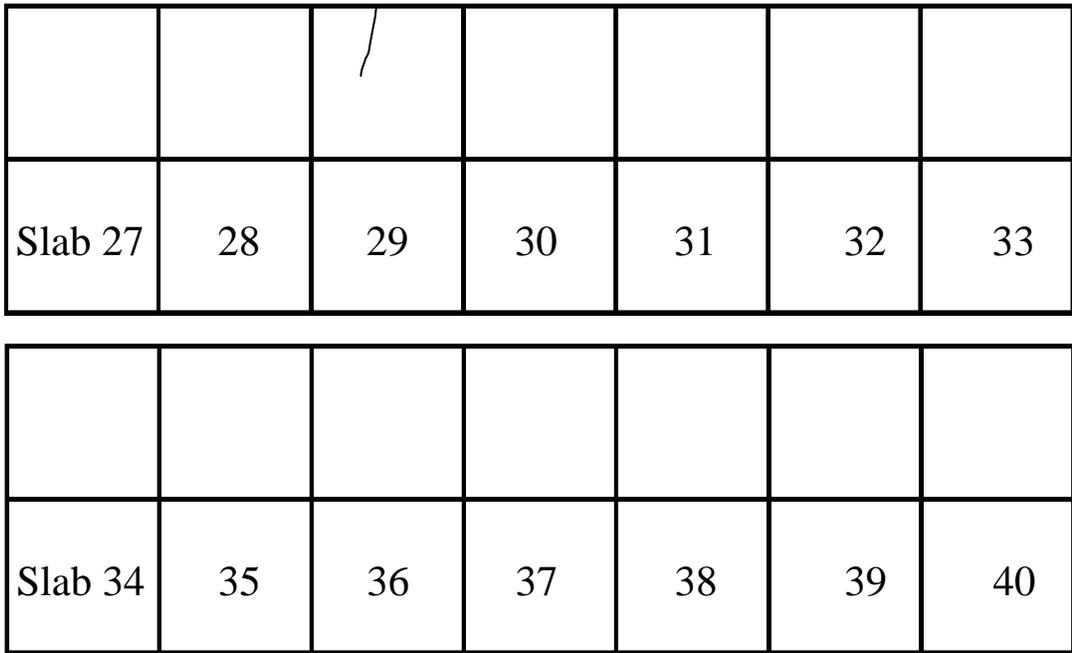
Figure 52. Section 2 north cracking performance after 3/30/09 testing (6 inch = 834,000 ESALs; 8 inch=730,000 ESALs).

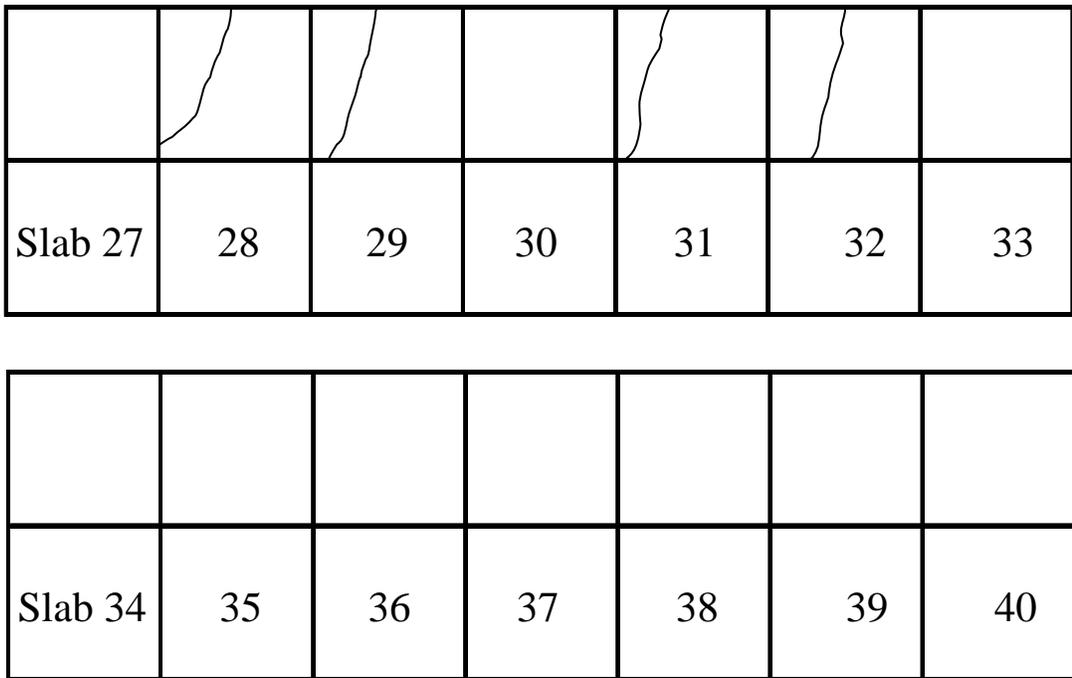
Figure 53. Section 2 north cracking performance after 4/6/09 testing (6 inch = 9.7 Million ESALs; 8 inch=8.5 Million ESALs).

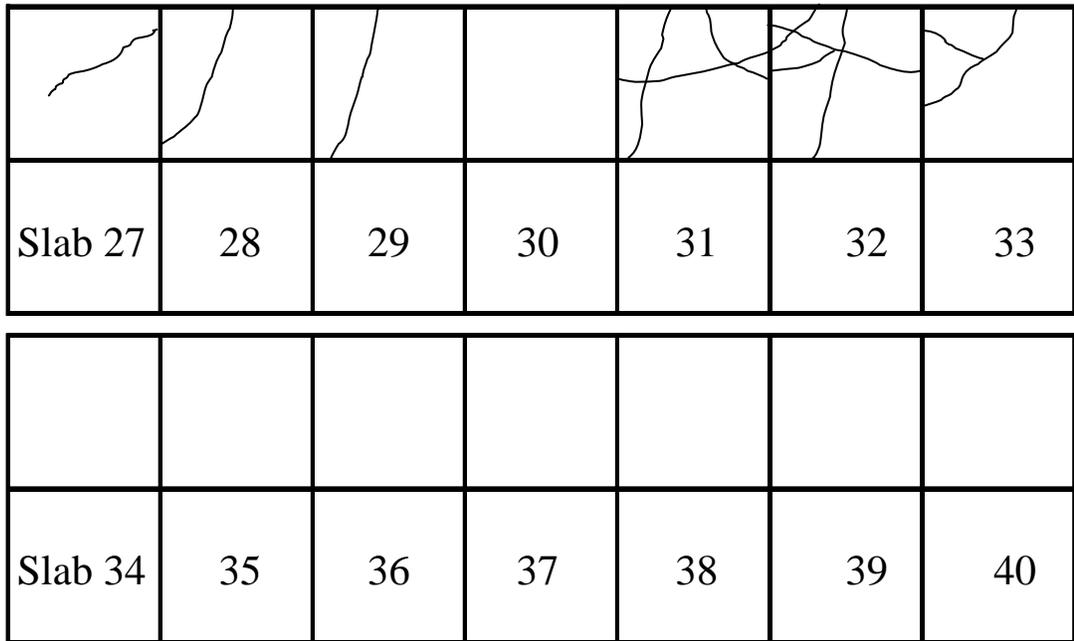
Figure 54. Section 2 north cracking performance after 4/10/09 testing (6 inch = 16.4 Million ESALs; 8 inch=14.3 Million ESALs).

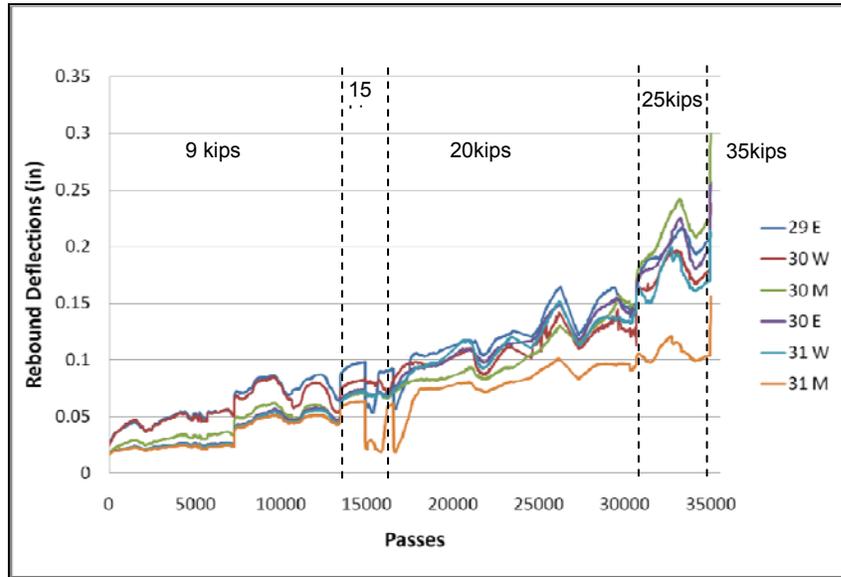
Figure 55. Rebound deflections of 6 in. concrete slab over granular base (Section 2-south).

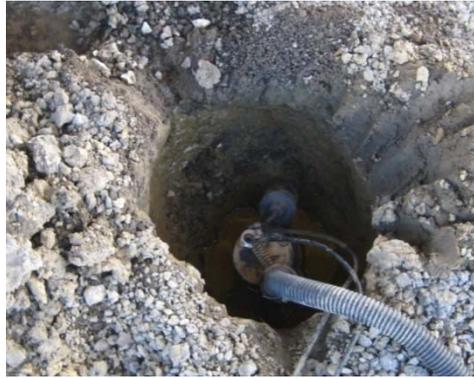
Figure 57. Water pump used to drain Section 2 North.
