PERFORMANCE OF CONCRETE PAVEMENTS WITH OPTIMIZED SLAB GEOMETRY

Prepared By
Victor Cervantes
Jeffery Roesler
University of Illinois at Urbana-Champaign

Research Report ICT-09-053

August 2009

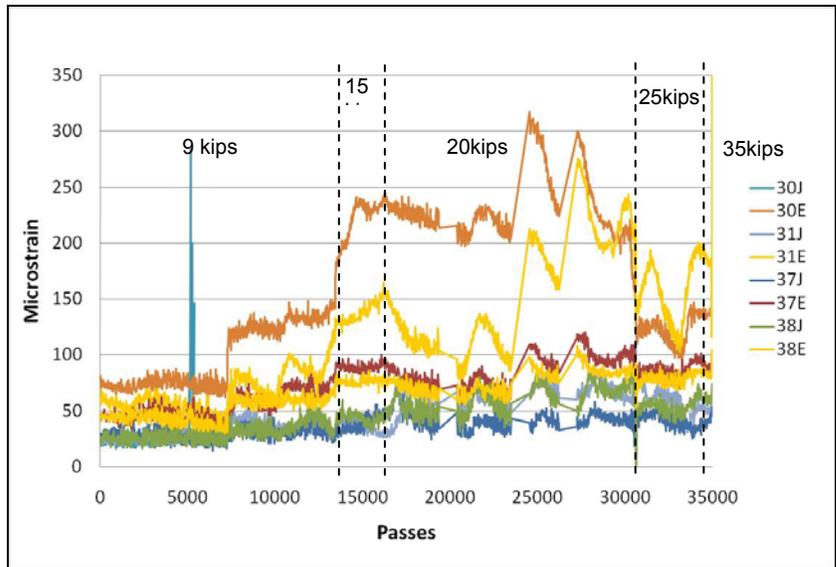
Figure 62. Maximum tensile strain responses for 6 and 8 in over granular base– (Section 2 – south)

Figure 62 shows the tensile strains in the 6 and 8 inch slabs while the wheel carriage was trafficking near the slab edge. The strains at the bottom edge of the slab were greater than the top of the slab at the transverse joint. Assuming uniform support beneath the slab, transverse cracking would be expected. Cracking appeared on the surface of the slabs after 30,000 passes of the wheel, which represented more than 16.4 million ESALs. There was one transverse crack and two corner breaks on the 6 inch section suggesting that a greater degree of deformation occurred in the support layers. The measured tensile strains in the 8 inch section were less than 100 microstrain for almost the entire loading period. After 19.6 million ESALs, there was no fatigue cracking observed on the 8 inch section, which was consistent with the magnitude of measured strain.

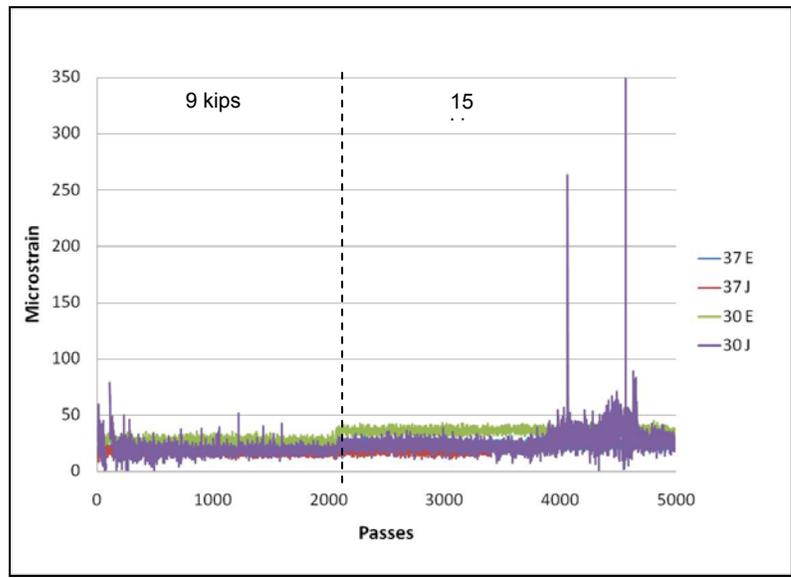
Figure 63. Tensile strains in 6 and 8 inch concrete slab over granular base for wheel path loading.

For section 2 (north), slab 30 was instrumented with strain gauges for the 6 inch section and slab 37 for the 8 inch section. Figure 63 shows the strains at 9 and 15-kips were very small for the wheel path loading. When the concrete slabs were tested near the free edge the tensile strain stayed below 100 microstrain as shown Figure 64, for both the 6 and 8 inch.

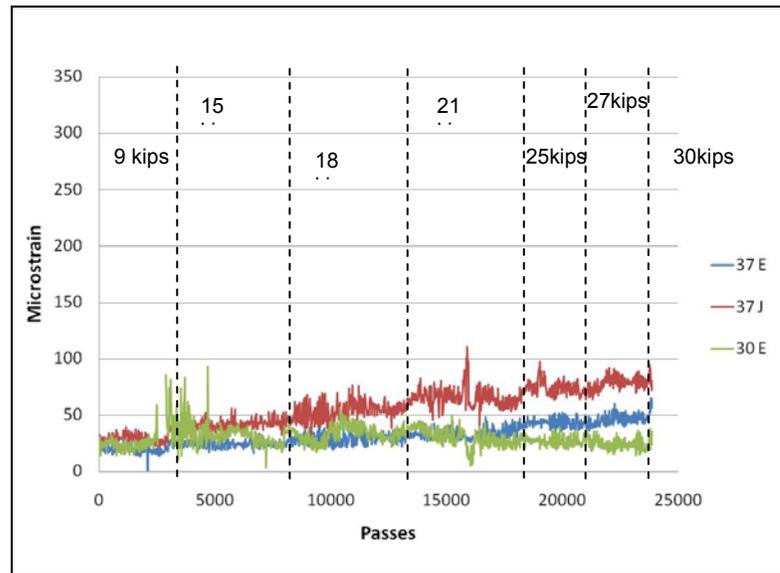
Figure 64. Tensile strains in 6 and 8 inch concrete slab over granular base for edge loading.

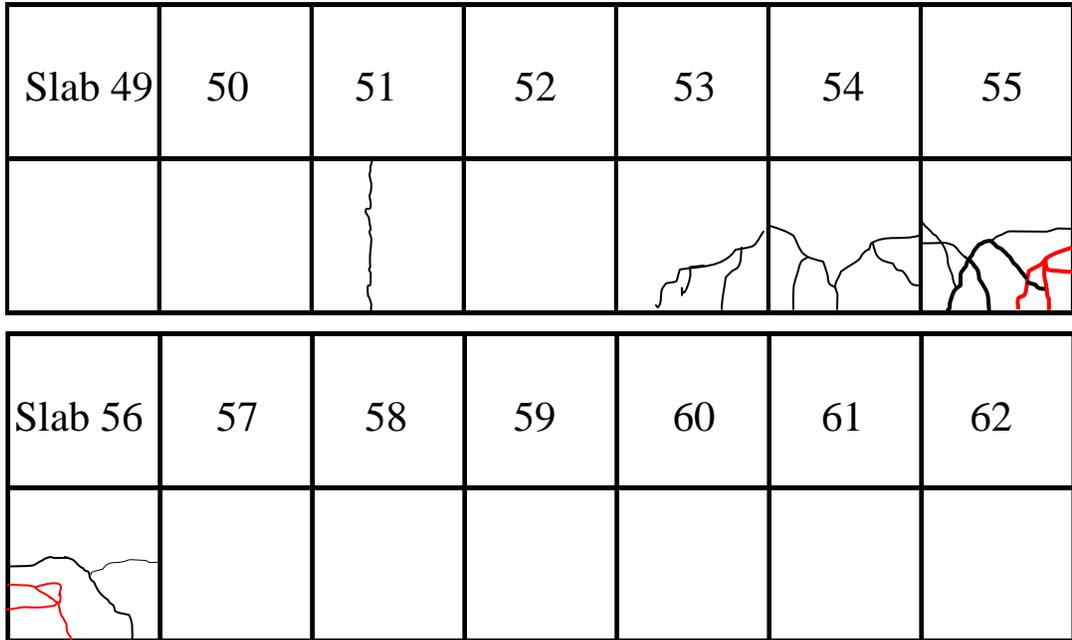
Figure 65. Section 3 south cracking performance after 4/19/08 testing (192,000 ESALs).

Figure 65 to Figure 67. By the end of the trafficking, all of the plain concrete slabs had cracked, while only 3 out of 7 slabs on the fiber reinforced section were cracked. The severity of the plain concrete distresses were much higher than the fiber reinforced concrete slabs. The plain concrete slabs were broken into smaller pieces compared to the fiber reinforced concrete slabs. The structural fibers added to the plain concrete demonstrated two benefits: the FRC slabs were able to resist fatigue cracking for a larger number of ESALs and maintain the continuity across fatigue cracks better than the plain concrete slabs.

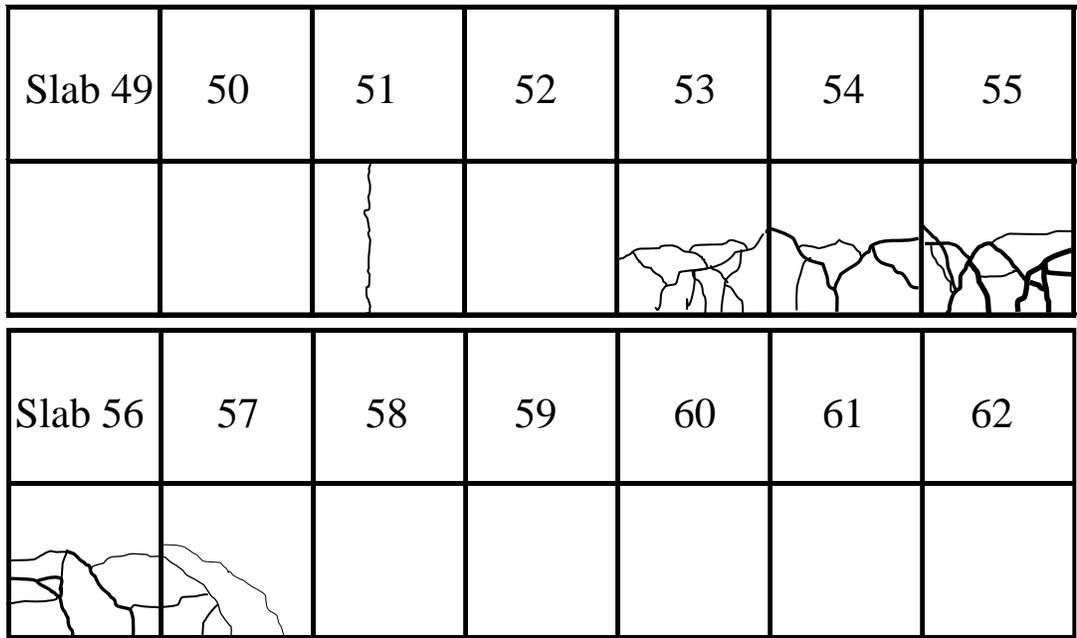
Figure 66. Section 3 south cracking performance after 4/21/08 testing (233,000 ESALs).

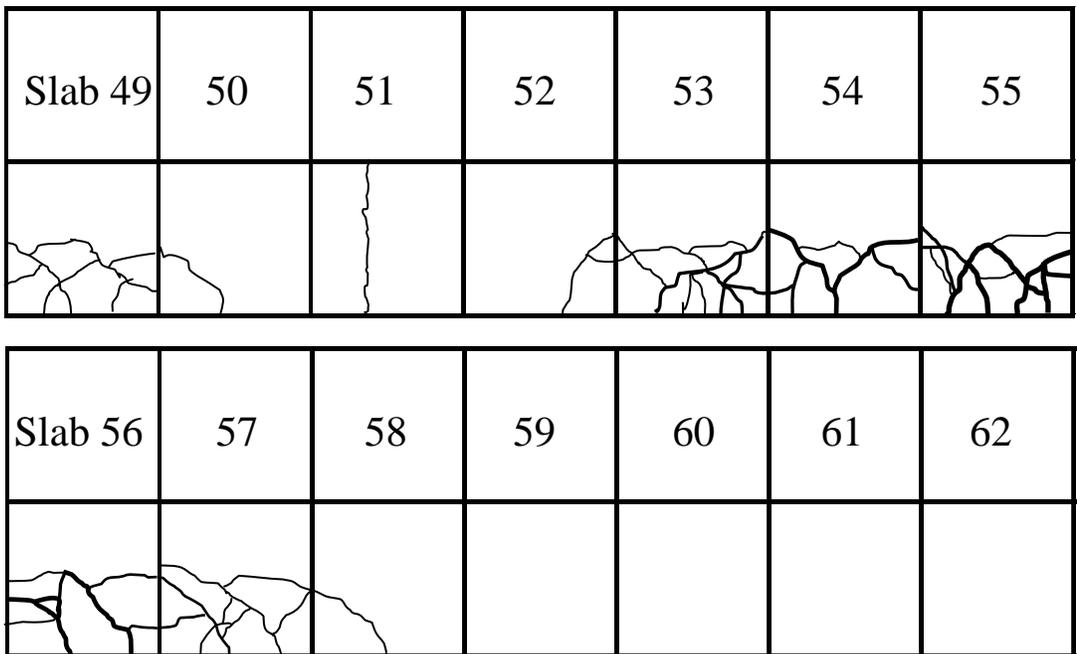
Figure 67. Section 3 south final cracking performance after 234,000 ESALs.

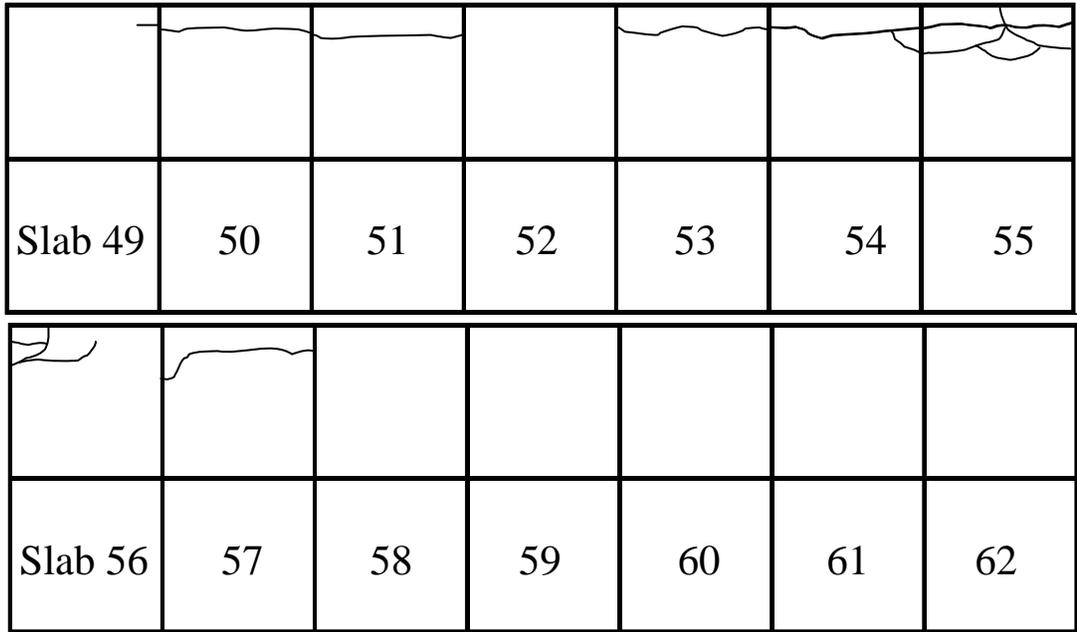
Figure 69. Wheel path testing Section 3 north FRC 3/9/09 (3,103 ESALs).

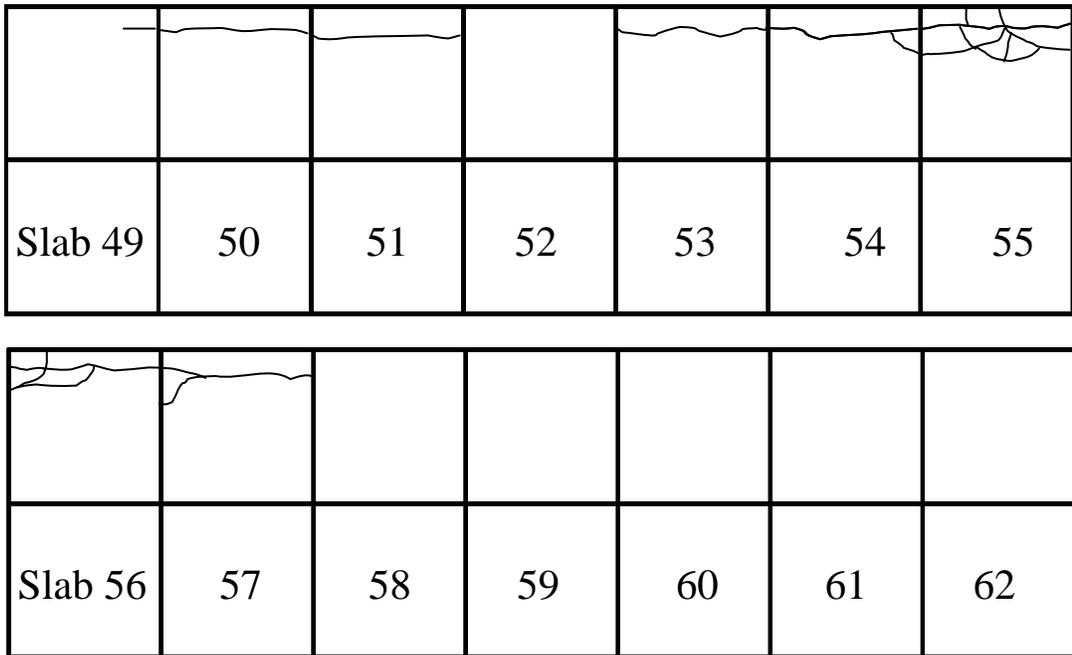
Figure 70. Wheel path testing Section 3 north 3/10/09 (4,545 ESALs).

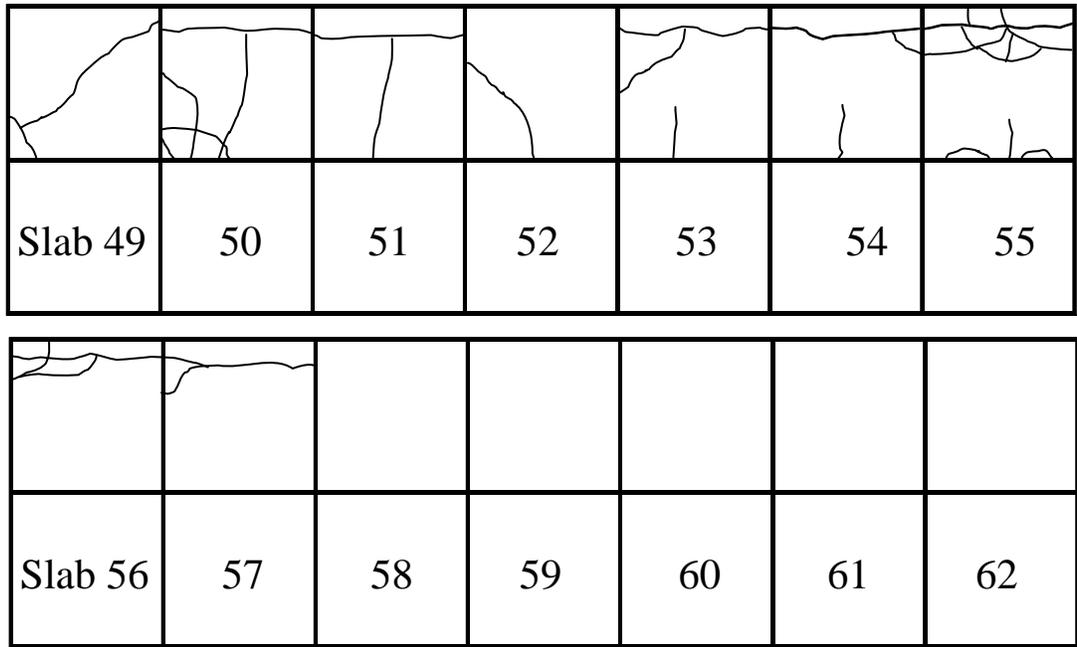
Figure 71. Longitudinal joint loading cracking pattern 3/14/09 (4,700 ESALs).

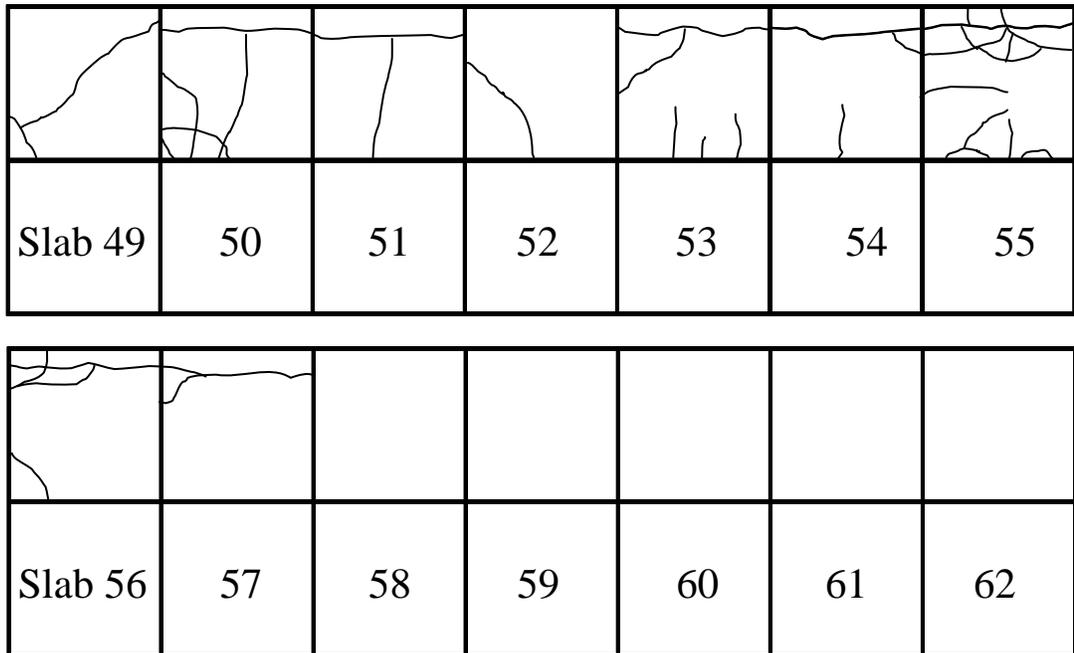
Figure 72. Cracking pattern for longitudinal joint trafficking on 3/15/09 (48,000 ESALs).

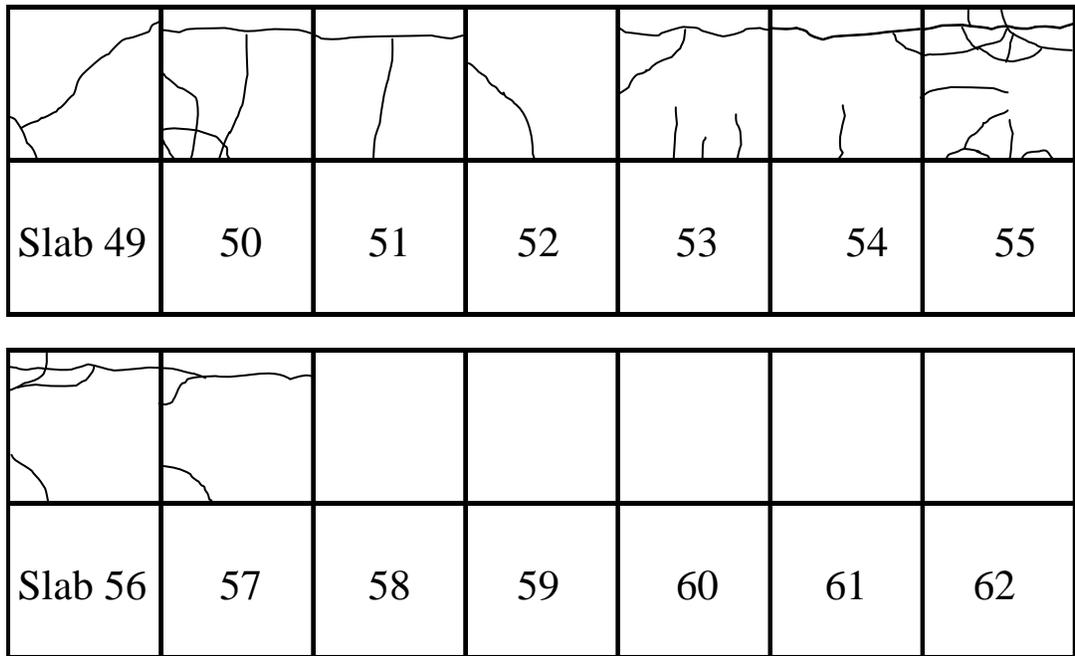
Figure 73. Cracking pattern for longitudinal joint trafficking on 3/16/09 (58,000 ESALs).

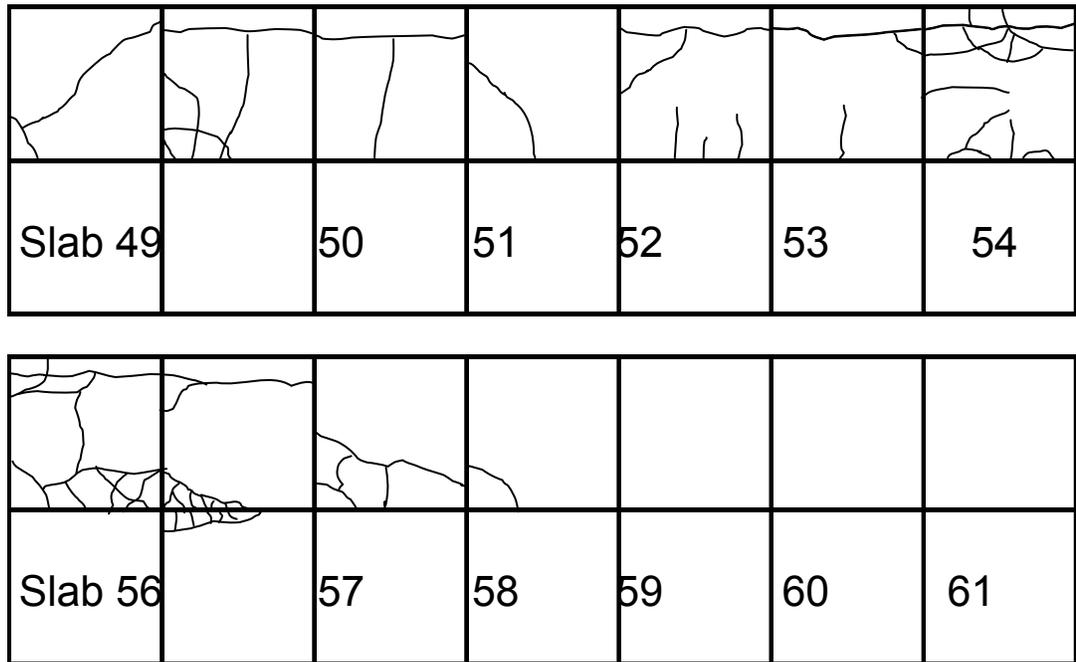
Figure 74. Cracking pattern for longitudinal joint trafficking on 3/19/09 (64,000 ESALs).

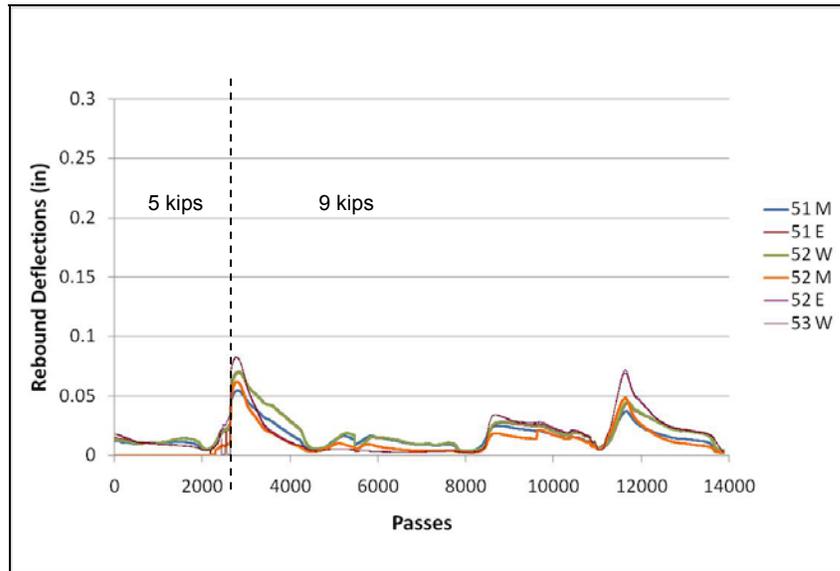
Figure 75. Rebound deflection of 3.5 in. plain concrete slab over a granular base during January 2008 (Section 3-south).

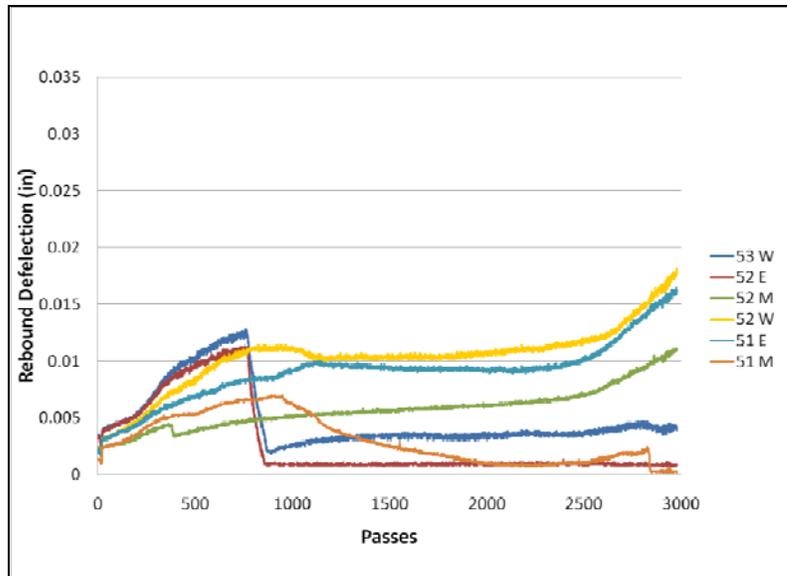
Figure 79. Wheel path rebound deflection of 3.5 in. plain concrete slab over a granular base (Section 3-south).

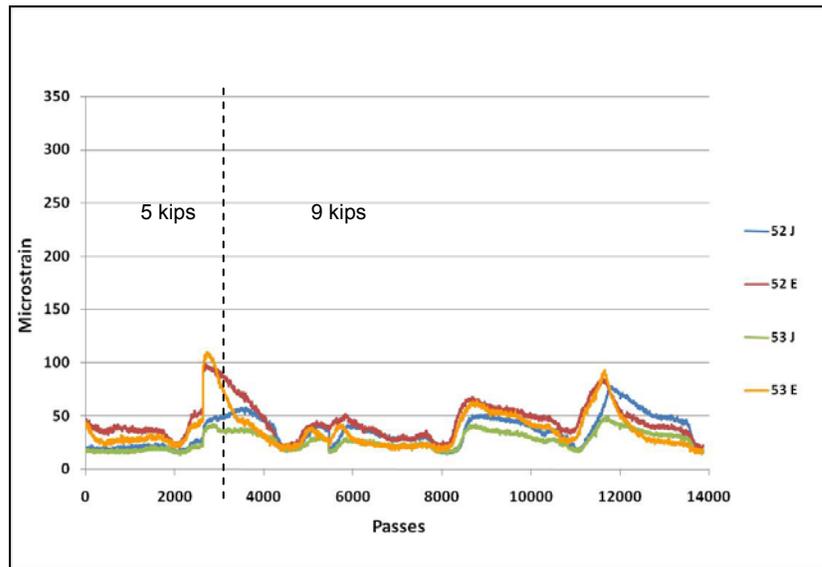
Figure 81. Maximum tensile strain responses for 3.5 in. plain over a granular base during Winter 2008 (Section 3 – south).

The strain responses from section 3 (south) in the winter time are seen in Figure 81 and Figure 82. The strain responses for section 3 (south) in the spring 2008 are seen in Figure 83. Testing at the 5-kip load level did not result in any cracks and the tensile strains were less than 100 microstrain. Figure 83 shows a rapid increase in tensile strain in the 3.5-inch plain concrete section when the load was increased to 9-kip. Strain gauge 53E, reached about 850 microstrain between 5000 and 10000 passes, which coincided with the first observed fatigue crack on the pavement surface. The strains for slab 52 stayed below 200 microstrain and did not crack until 12-kips were applied to the pavement. The plot also shows that for slabs 58 and 59 the maximum tensile strain was measured along the edge between 150 and 200 microstrain. Slab 58 eventually cracked during the trafficking of the wheel at 12-kips.

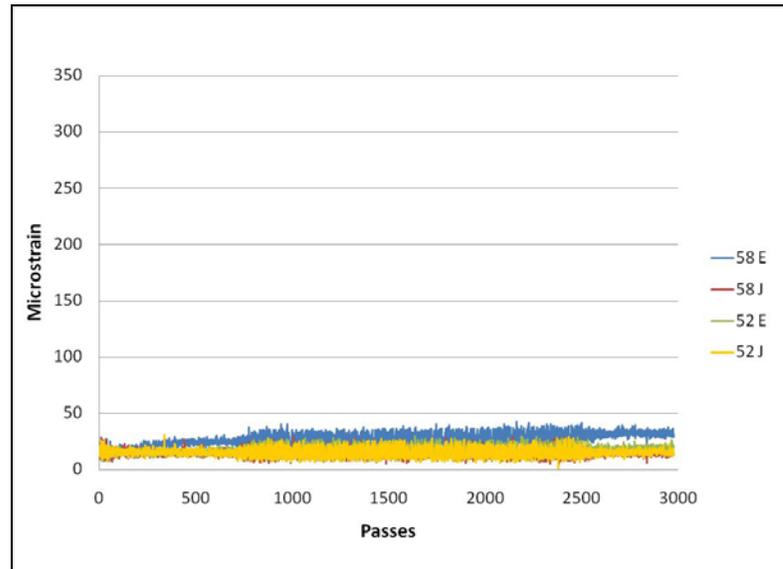
Figure 84. Wheel path maximum tensile strain responses for 3.5 in. plain and FRC over a granular base (Section 3 – north).

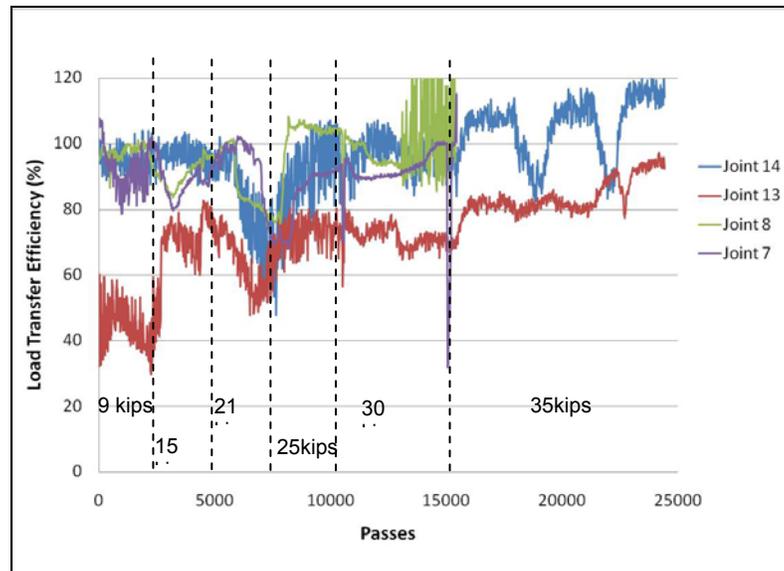
Figure 87. Deflection load transfer efficiency at free edge (Section 1 – North).

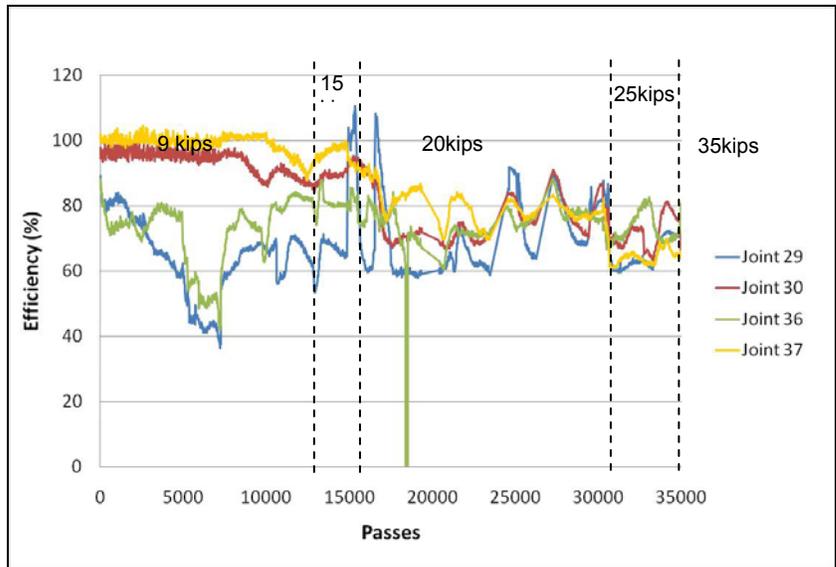
Figure 88. Deflection load transfer efficiency for edge loading (Section 2 – south).

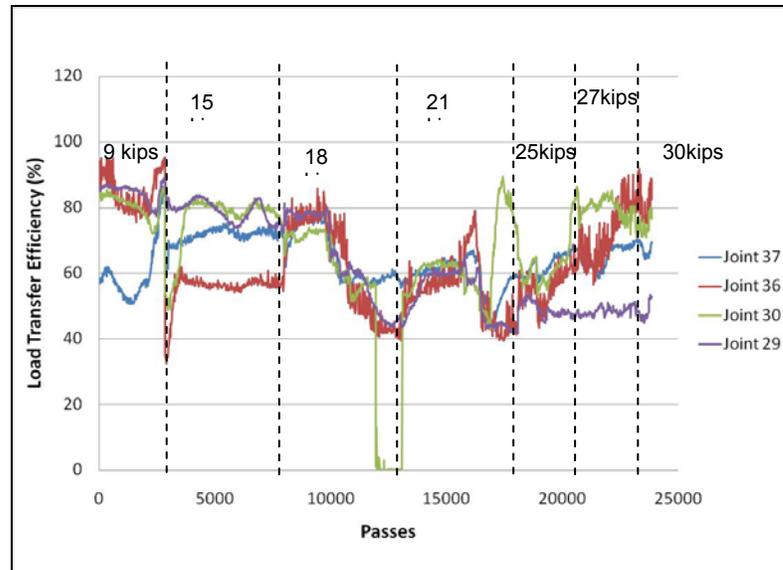
Figure 90. Deflection load transfer efficiency at free edge loading (Section 2 – north).

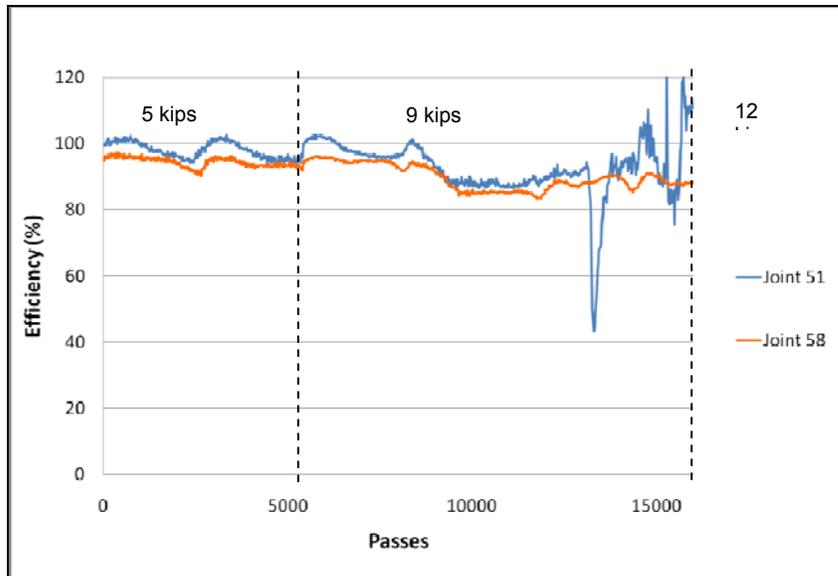
Figure 91. Deflection load transfer efficiency for edge loading (Section 3 – south).

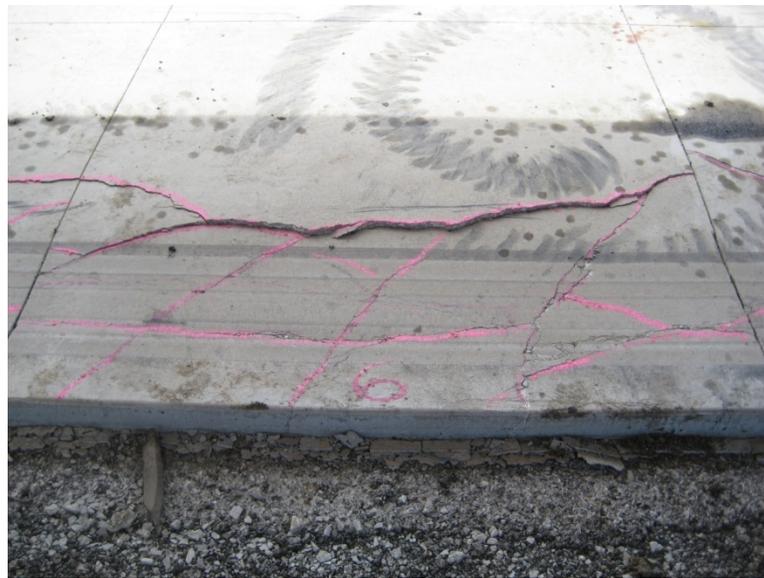
Figure 93. Fatigue cracking of 4 in. concrete slab over asphalt base on section 1 north at 20 million ESALs.

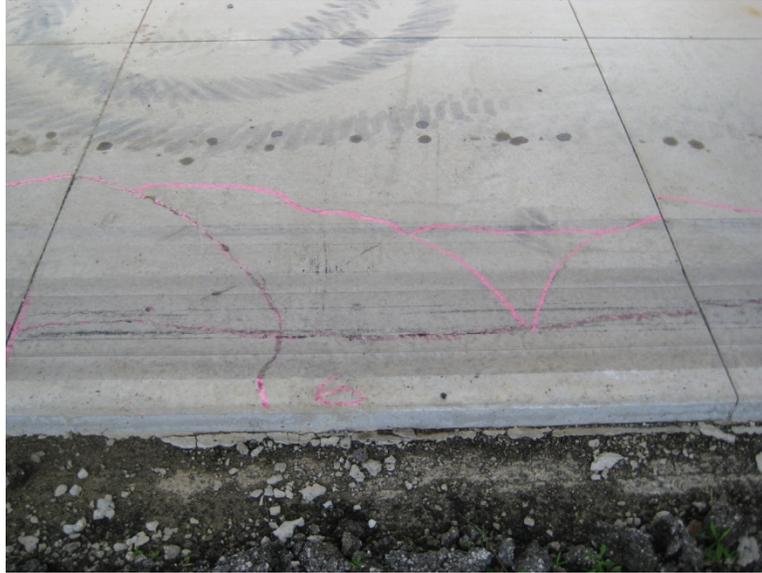
Figure 94. Fatigue cracking of 4 in. concrete slab over asphalt base on section 1 south at 56 million ESALs.

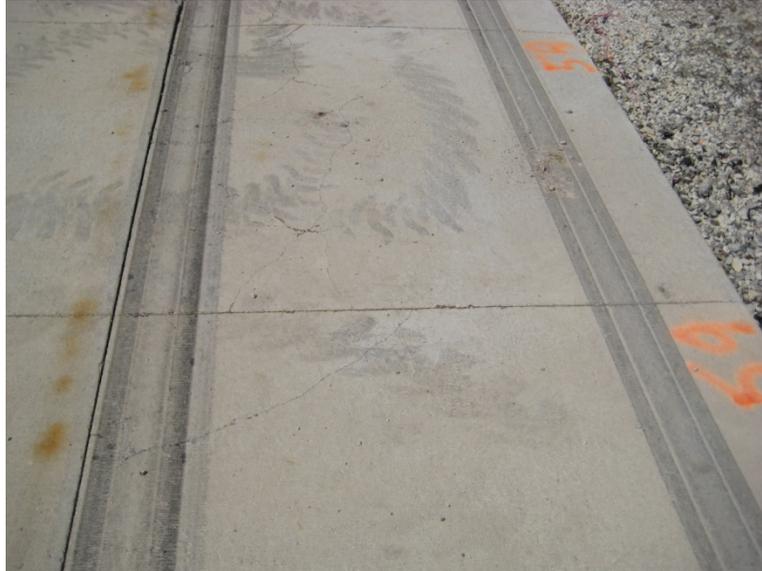
Figure 97. Longitudinal joint opening on 3.5 inch plain concrete section.

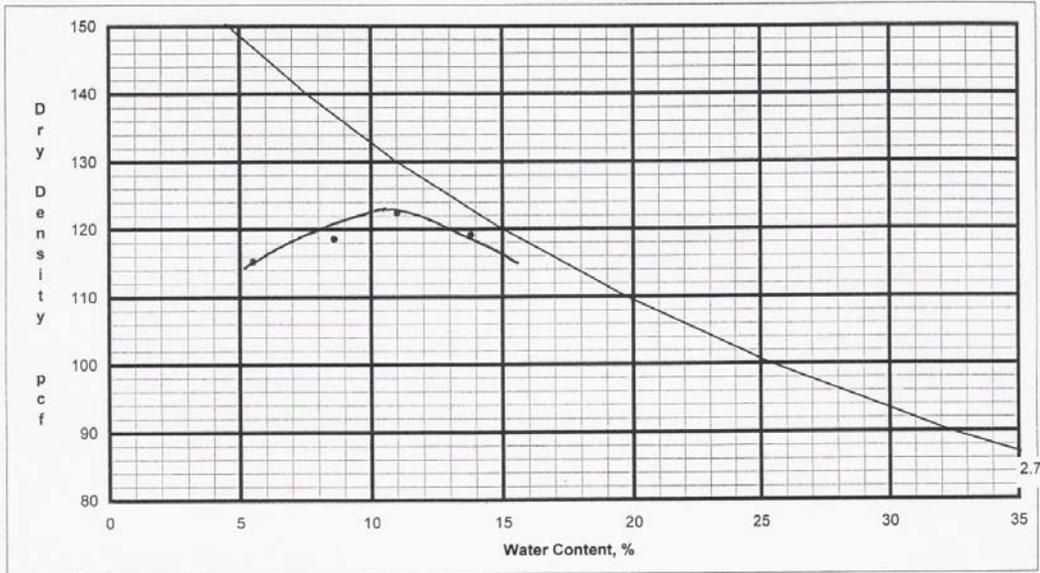
Modified Proctor Test (ASTM D1557, method A)
